## 2014-18 GMC SIERRA LH UPR OUTBOARD HEADLIGHT TAB KIT ALL P/N 25-10006

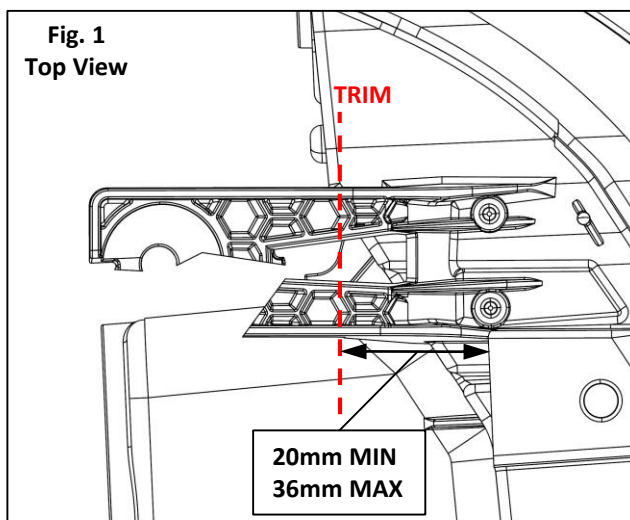
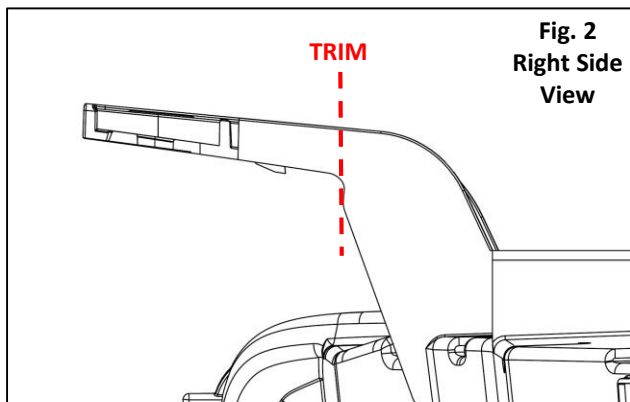
**1. Trim:** Using a cut-off wheel, trim the damaged tab to the **MAX** dimension whenever possible, **Fig. 1**. Make note of the trimming plane to which the **MAX** dimension refers, **Fig. 2**. The **MIN** indicates the least amount of material allowed for proper screw engagement. Next, Sand rough edges to remove excess material from trimming and to ensure a proper fit.

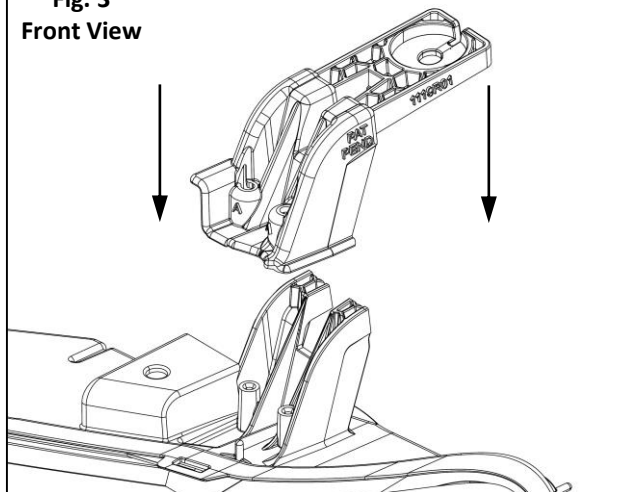
**Fig. 3**  
Front View

**2. Dry-Fit:** Dry-fit the repair tab(s) **Fig. 3**. If the tab fits without resistance and makes a flush fit to the housing, trimming is complete. If the tab resists installation re-trim the damaged tab, removing only small amounts of material. Repeat the Dry-Fit steps until the proper fit is achieved.

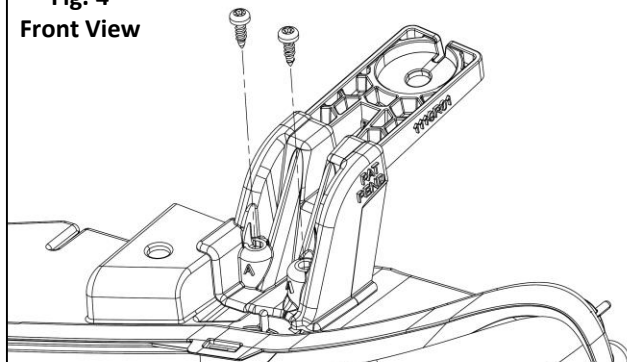
**Fig. 4**  
Front View

**4. Install:** Install the prepared tab(s) ensuring a flush fit to the housing **Fig. 4**. Next, drive the two 5/8" screws at the locations marked (A). Do not over-tighten the screws. Allow the glue to cure for approximately 30 minutes before installing the repaired headlight on the vehicle.

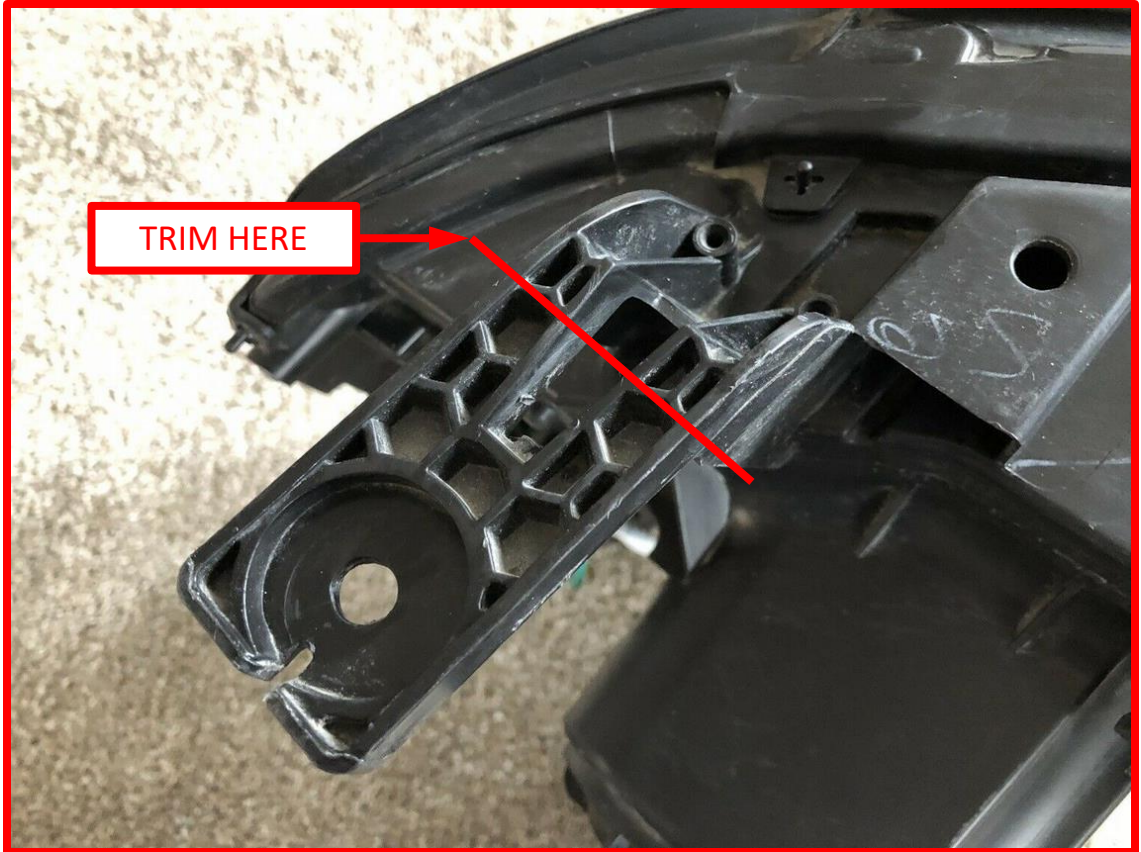
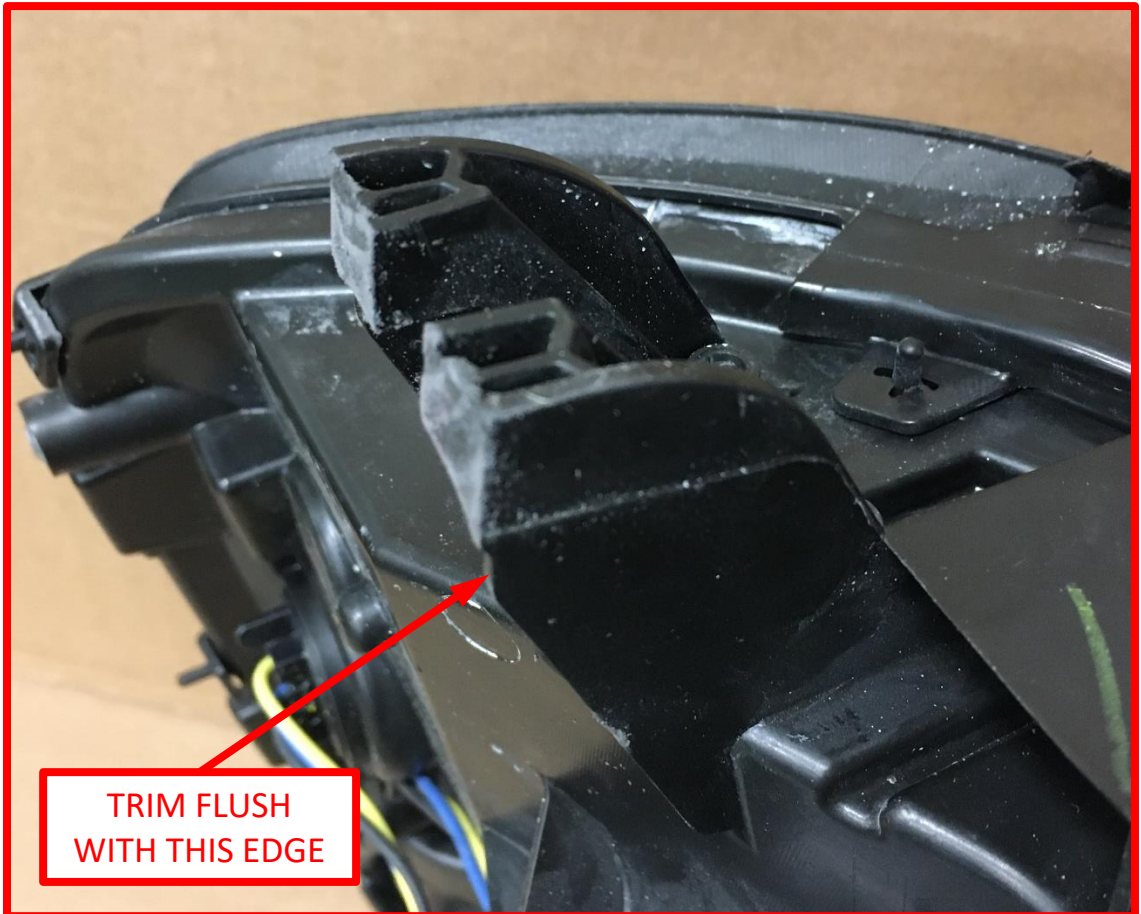
SEE REVERSE SIDE for views of properly trimmed headlamp tab.
