2014-18 GMC SIERRA RH LWR OUTBOARD HEADLIGHT TAB KIT ALL P/N 25-10003

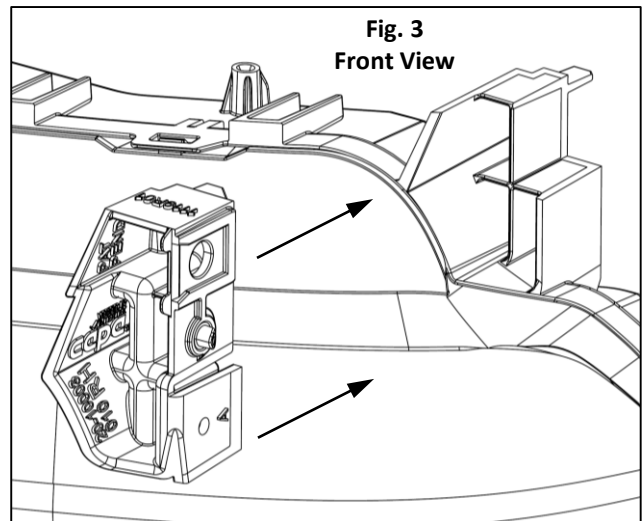
2. Dry-Fit: Dry-fit the repair tab(s) **Fig. 3**. If the tab fits without resistance and makes a flush fit to the housing, trimming is complete. If the tab resists installation re-trim the damaged tab, removing only small amounts of material. Repeat the Dry-Fit steps until the proper fit is achieved.

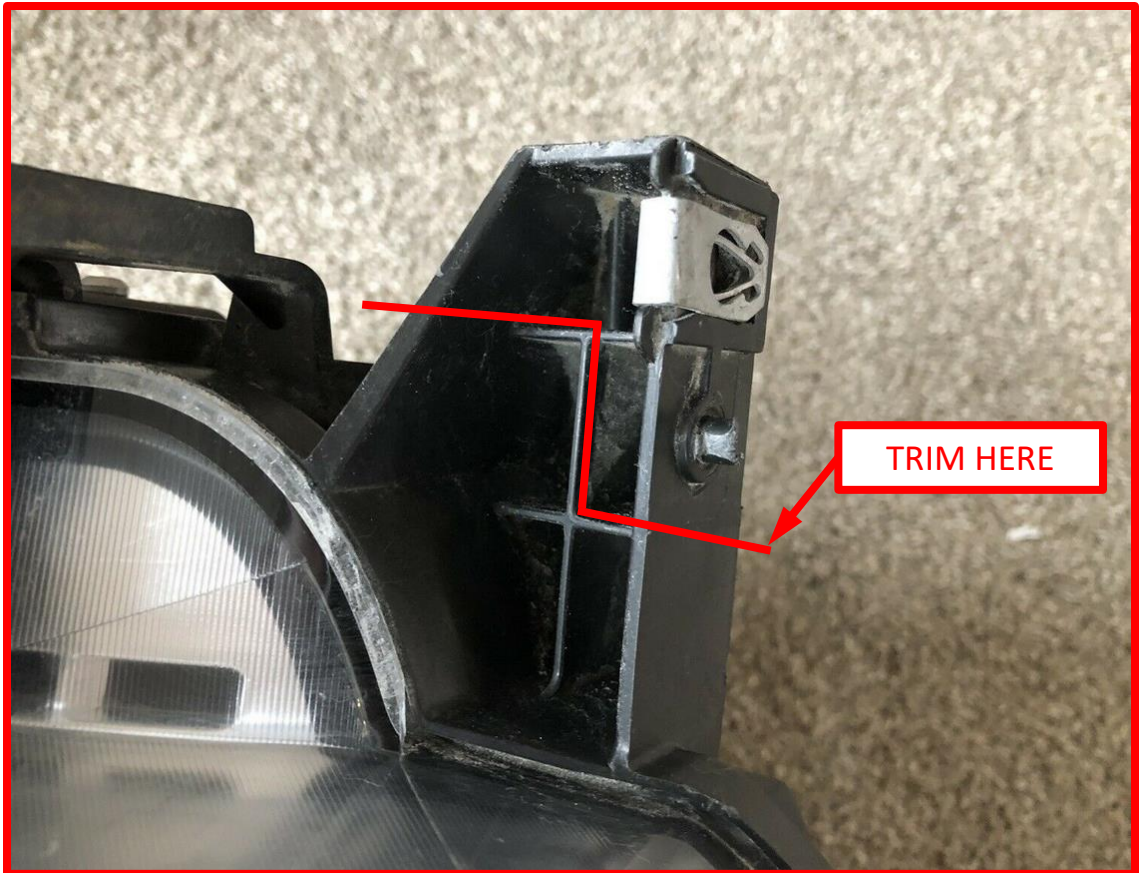
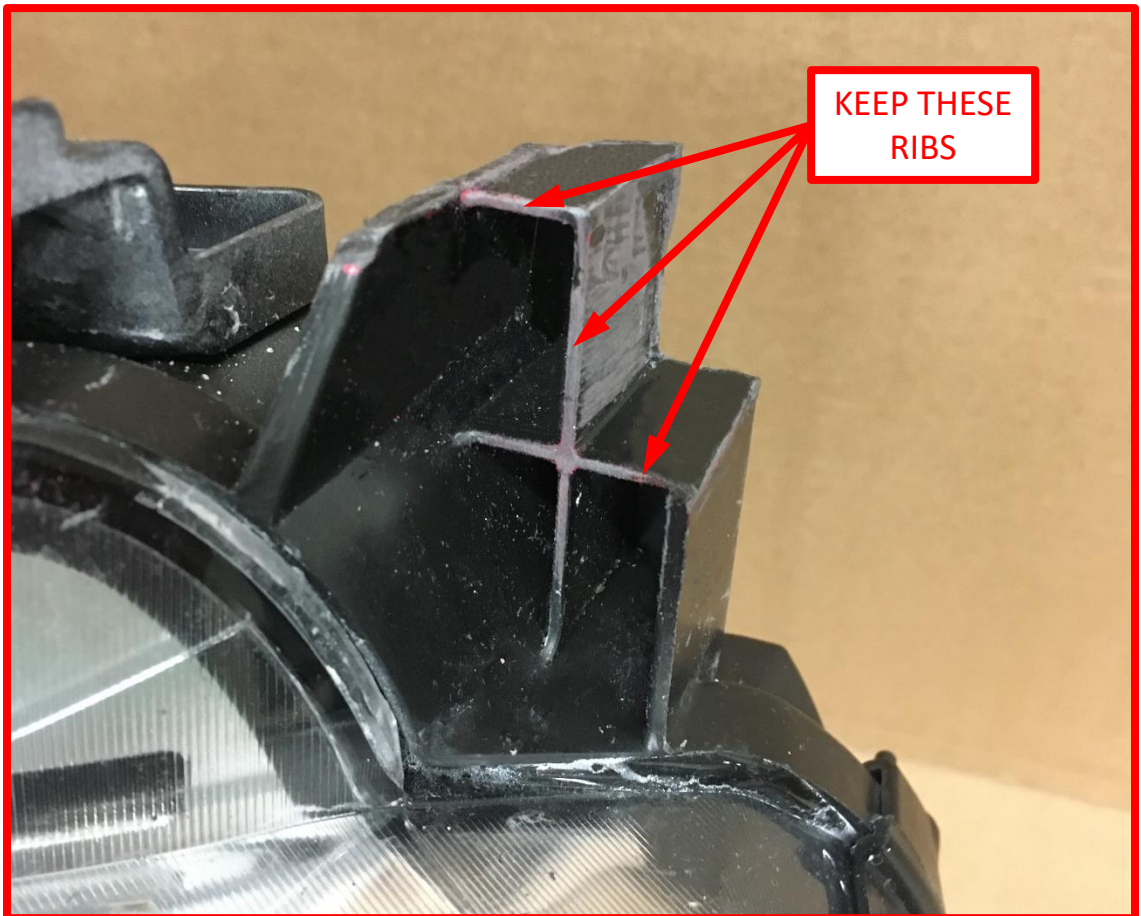
SEE REVERSE SIDE for views of properly trimmed headlamp tab.
