2014-18 GMC SIERRA RH UPR OUTBOARD HEADLIGHT TAB KIT ALL P/N 25-10002

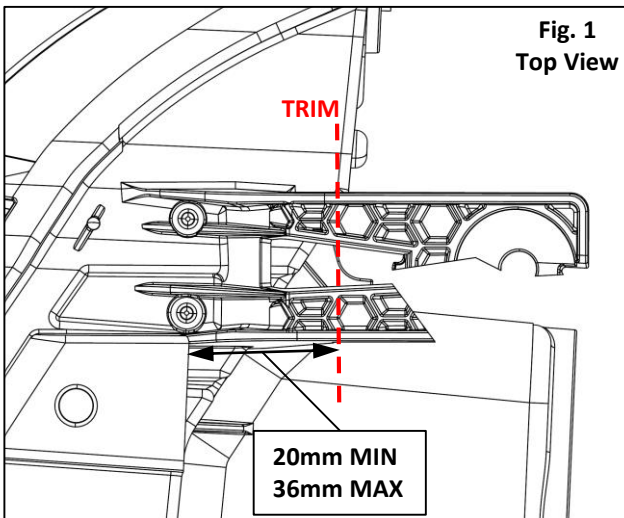
1. Trim: Using a cut-off wheel, trim the damaged tab to the **MAX** dimension whenever possible, **Fig. 1**. Make note of the trimming plane to which the **MAX** dimension refers, **Fig. 2**. The **MIN** indicates the least amount of material allowed for proper screw engagement. Next, Sand rough edges to remove excess material from trimming and to ensure a proper fit.

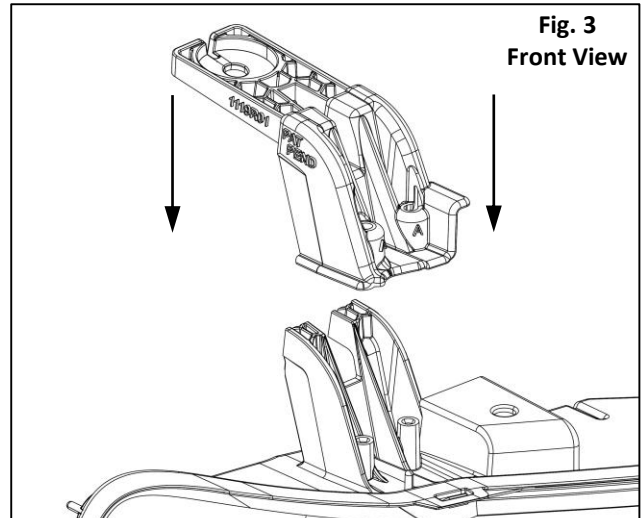
2. Dry-Fit: Dry-fit the repair tab(s) **Fig. 3**. If the tab fits without resistance and makes a flush fit to the housing, trimming is complete. If the tab resists installation re-trim the damaged tab, removing only small amounts of material. Repeat the Dry-Fit steps until the proper fit is achieved.

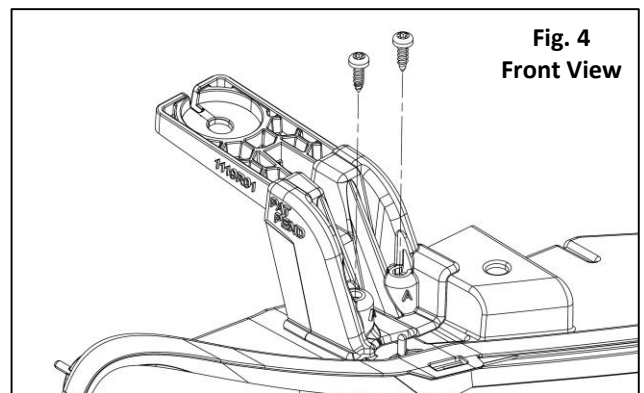
4. Install: Install the prepared tab(s) ensuring a flush fit to the housing **Fig. 4**. Next, drive the two 5/8" screws at the locations marked (A). Do not overtighten the screws. Allow the glue to cure for approximately 30 minutes before installing the repaired headlight on the vehicle.

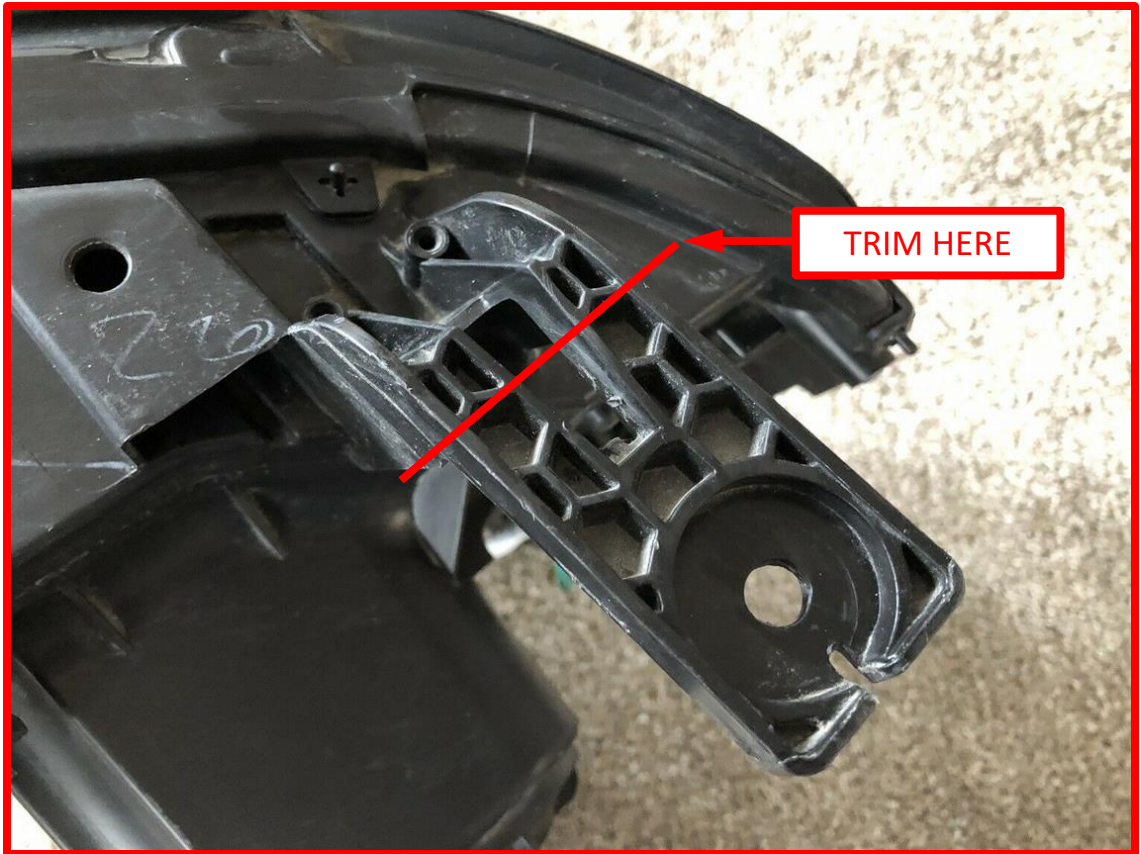
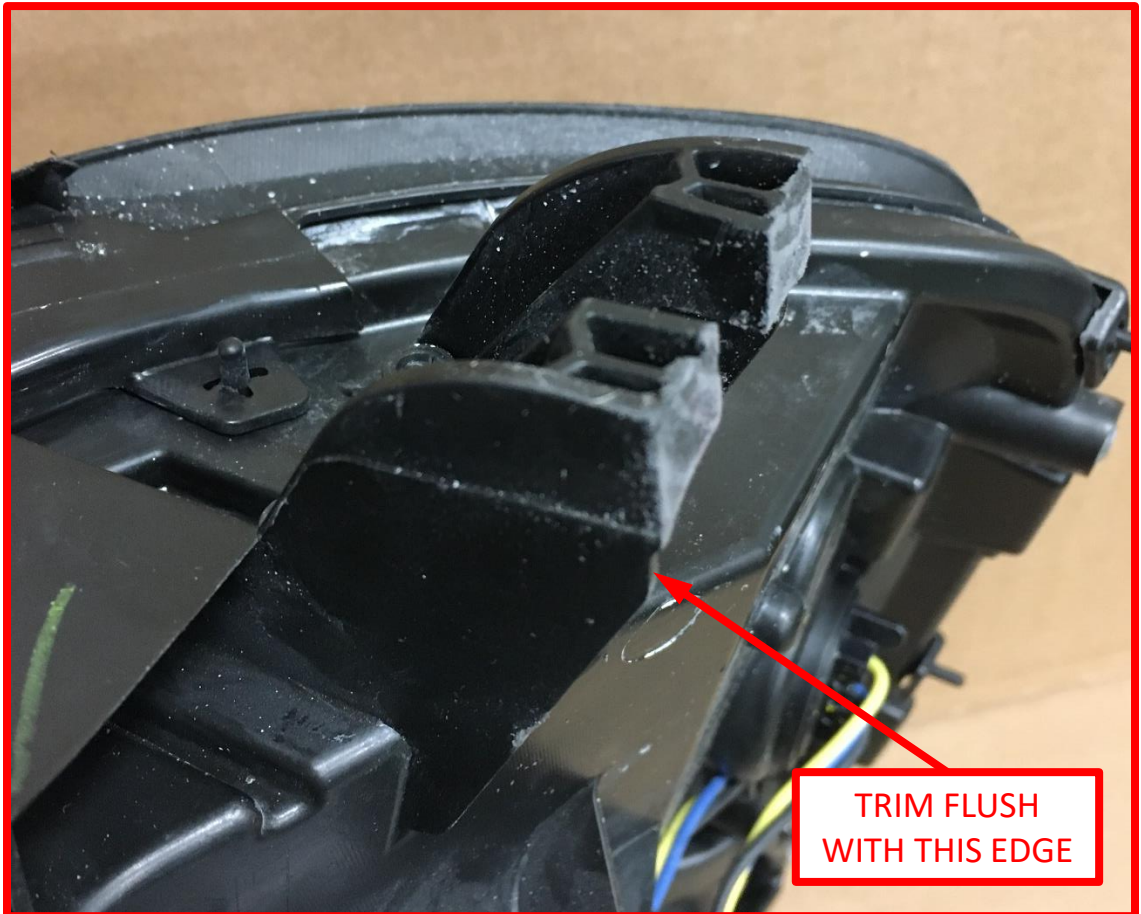
SEE REVERSE SIDE for views of properly trimmed headlamp tab.
