**Minimum Material Condition (MMC)**  
**2016-18 CHEVY SILVERADO 1500 HID LED LH LWR INBOARD HEADLIGHT TAB KIT**  
**P/N 25-10044**

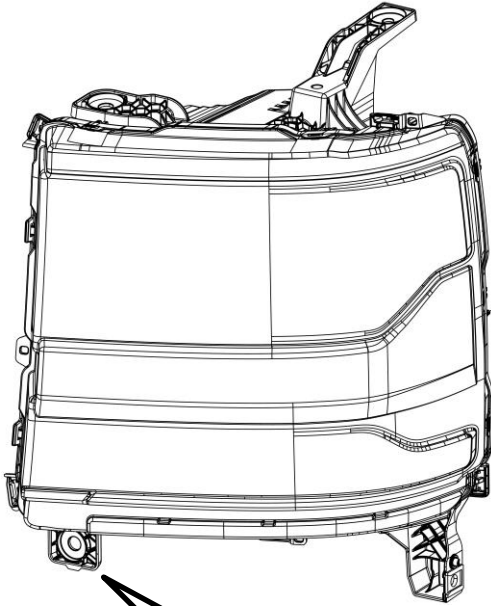
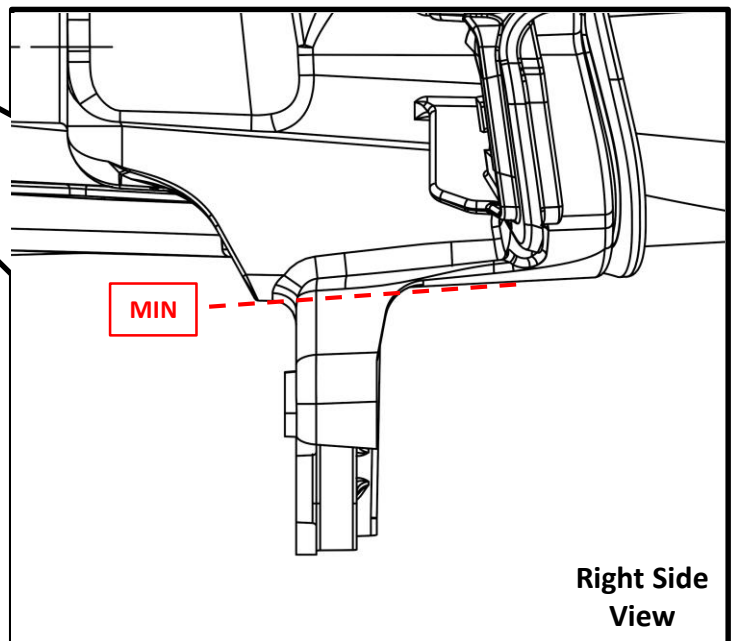
1. Using a metric scale or ruler, measure your lamp at the reference points given in the figure below.
2. If the broken mounting tab meets the Minimum Material Condition value(MIN), then your lamp can be repaired using this kit.
3. If the broken mounting tab does not meet the Minimum Material Condition value(MIN), then your lamp is not a candidate for this repair kit.
4. If your lamp's mounting tabs have been repaired previously by any method, then your lamp is not a candidate for this repair kit.
