Minimum Material Condition (MMC)
2016-18 CHEVY SILVERADO 1500 HID LED LH UPR OUTBOARD HEADLIGHT TAB
P/N 25-10042

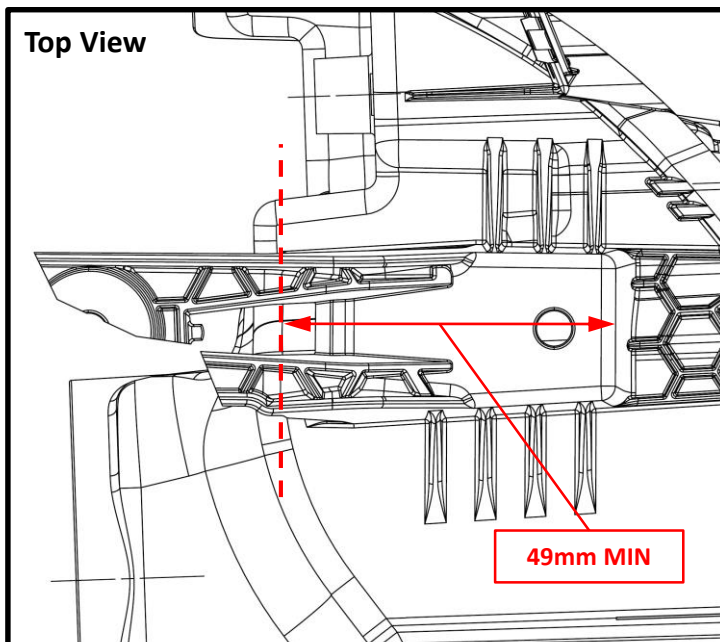
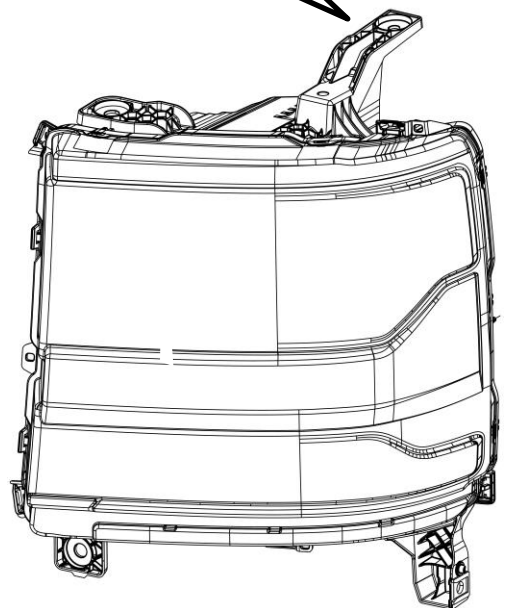
1. Using a metric scale or ruler, measure your lamp at the reference points given in the figure below.
2. If the broken mounting tab meets the Minimum Material Condition value(MIN), then your lamp can be repaired using this kit.
3. If the broken mounting tab does not meet the Minimum Material Condition value(MIN), then your lamp is not a candidate for this repair kit.
4. If your lamp's mounting tabs have been repaired previously by any method, then your lamp is not a candidate for this repair kit.
