**Minimum Material Condition (MMC)**  
**2016-18 CHEVY SILVERADO 1500 HID LED RH LWR INBOARD HEADLIGHT TAB KIT**  
**P/N 25-10040**

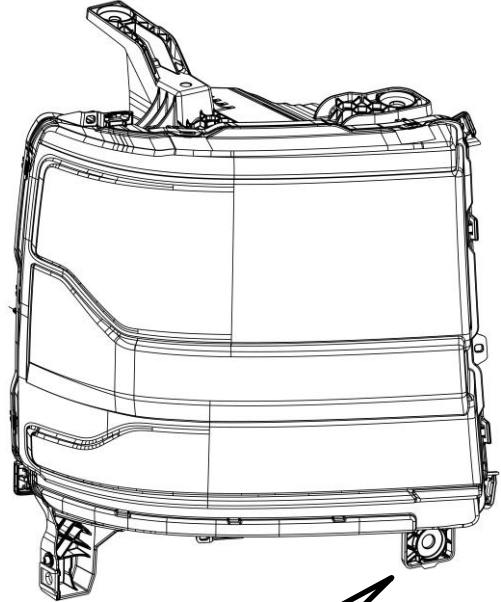
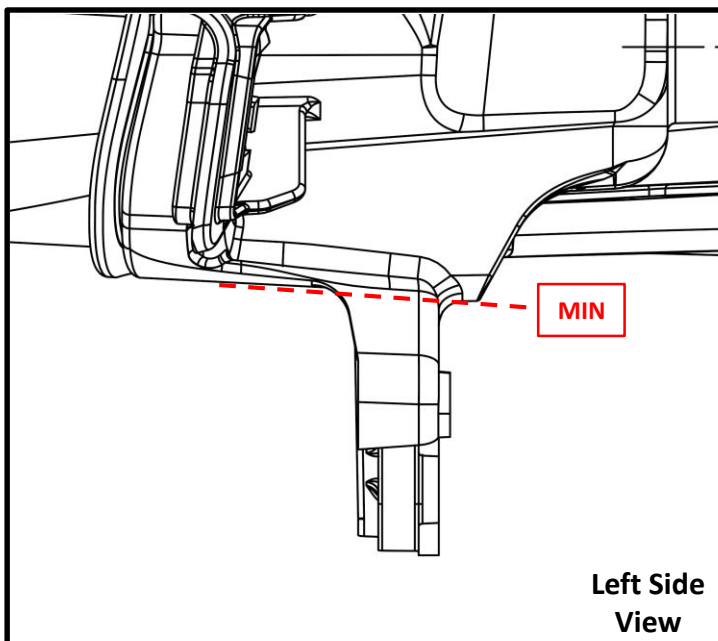
1. Using a metric scale or ruler, measure your lamp at the reference points given in the figure below.
2. If the broken mounting tab meets the Minimum Material Condition value(MIN), then your lamp can be repaired using this kit.
3. If the broken mounting tab does not meet the Minimum Material Condition value(MIN), then your lamp is not a candidate for this repair kit.
4. If your lamp's mounting tabs have been repaired previously by any method, then your lamp is not a candidate for this repair kit.
