Minimum Material Condition (MMC)
2016-18 CHEVY SILVERADO 1500 HID LED RH UPR INBOARD HEADLIGHT TAB KIT
P/N 25-10037

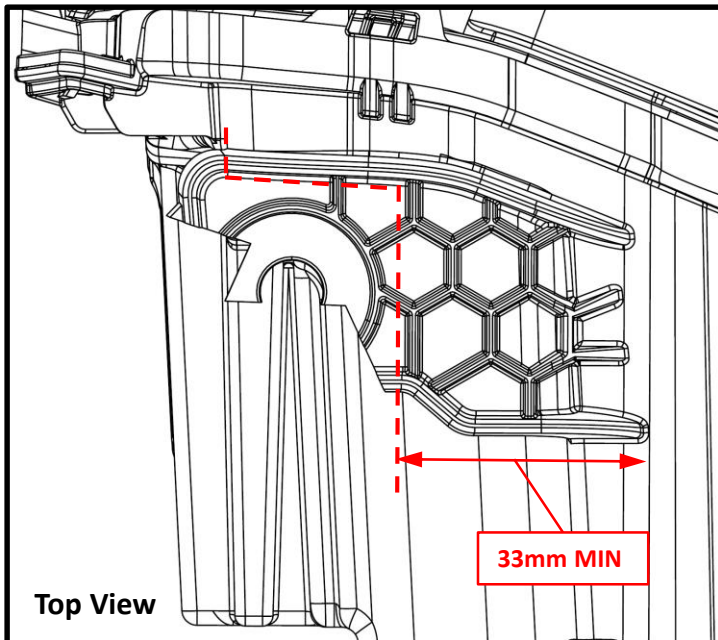
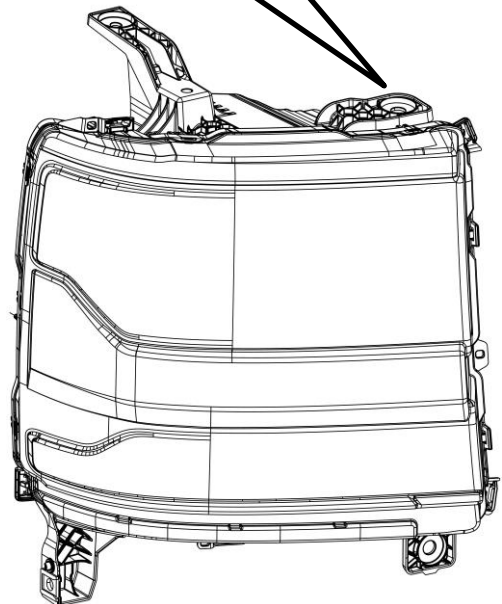
1. Using a metric scale or ruler, measure your lamp at the reference points given in the figure below.
2. If the broken mounting tab meets the Minimum Material Condition value(MIN), then your lamp can be repaired using this kit.
3. If the broken mounting tab does not meet the Minimum Material Condition value(MIN), then your lamp is not a candidate for this repair kit.
4. If your lamp's mounting tabs have been repaired previously by any method, then your lamp is not a candidate for this repair kit.
