2016-18 CHEVY SILVERADO 1500 HID LED RH LWR INBOARD HEADLIGHT TAB KIT P/N 25-10040

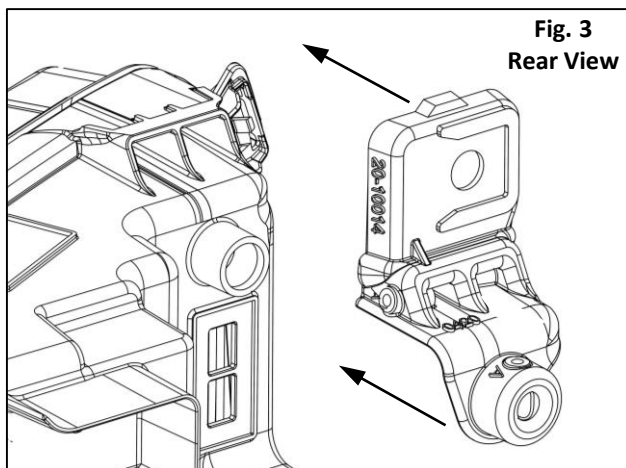
2. Dry-Fit: Dry-fit the repair tab(s) **Fig. 3**. If the tab fits without resistance and makes a flush fit to the housing, trimming is complete. If the tab resists installation re-trim the damaged tab, removing only small amounts of material. Repeat the Dry-Fit steps until the proper fit is achieved.

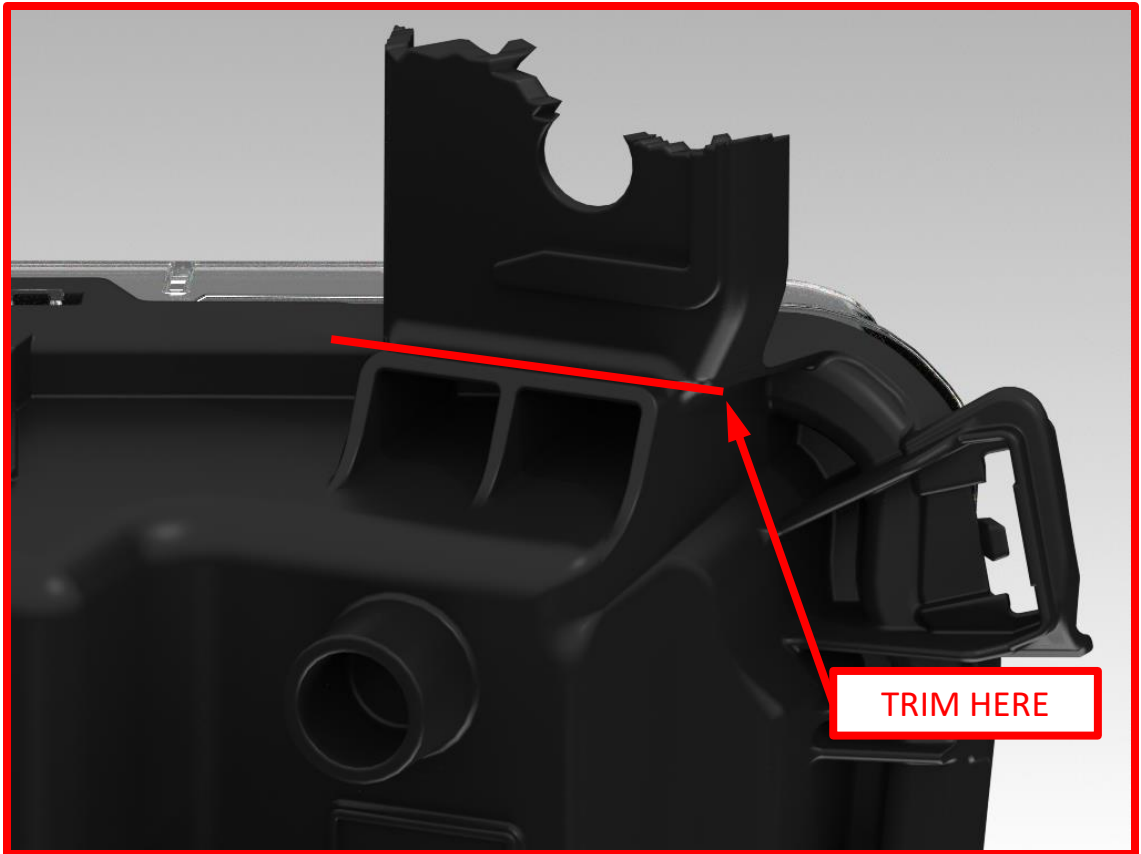
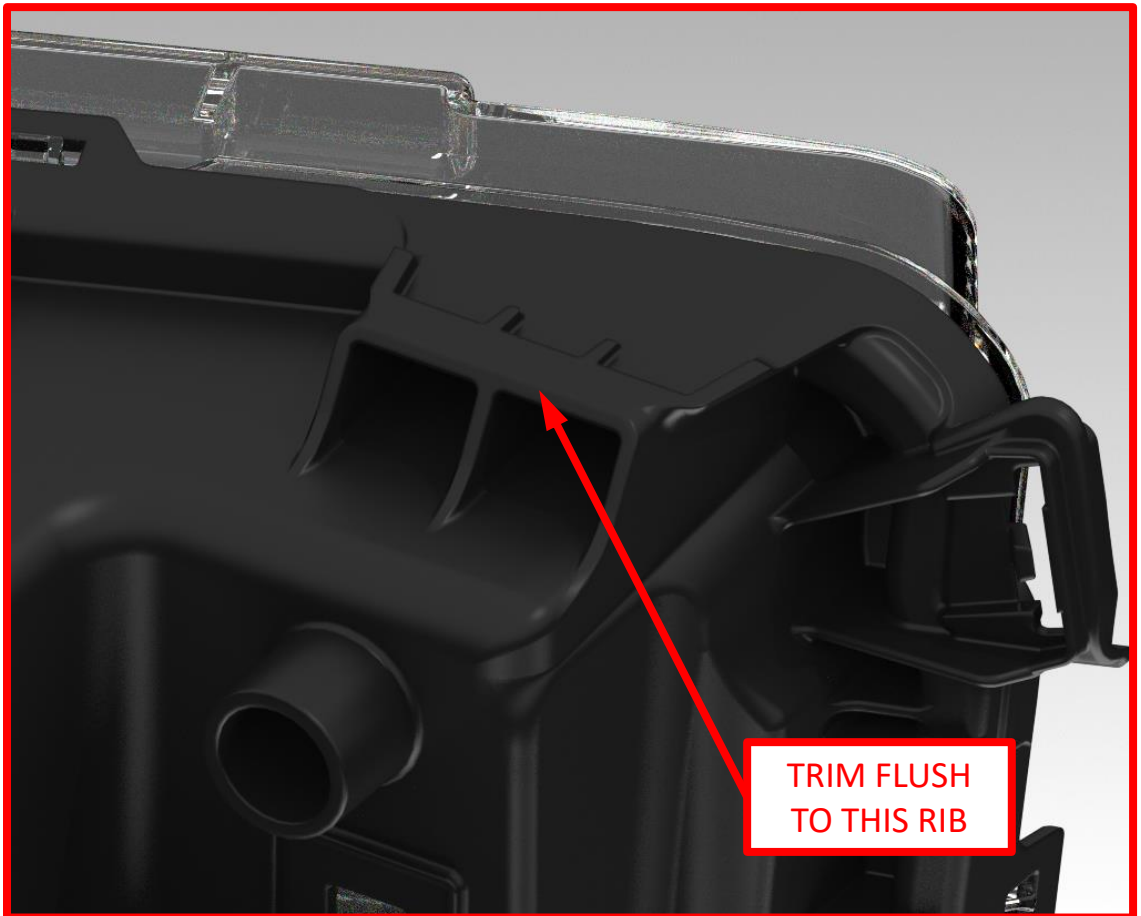
SEE REVERSE SIDE for views of properly trimmed headlamp tab.
