## 2016-18 CHEVY SILVERADO 1500 HID LED RH UPR INBOARD HEADLIGHT TAB KIT P/N 25-10037

(Please visit [CreativeRepairSolutions.com](http://CreativeRepairSolutions.com) for detailed instruction videos.)

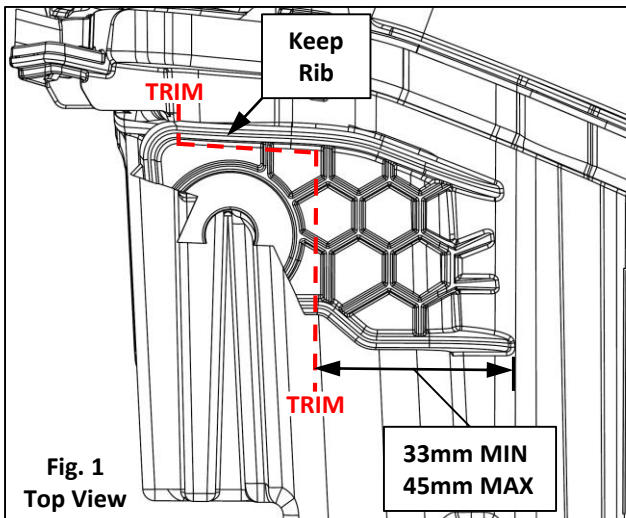
**1. Trim:** Using a cut-off wheel, trim the damaged tab to the **MAX** dimension whenever possible, **Fig. 1**. Make note of the trimming plane to which the **MAX** dimension refers, **Fig. 2**. The **MIN** indicates the least amount of material allowed for proper screw engagement. Next, Sand rough edges to remove excess material from trimming and to ensure a proper fit.

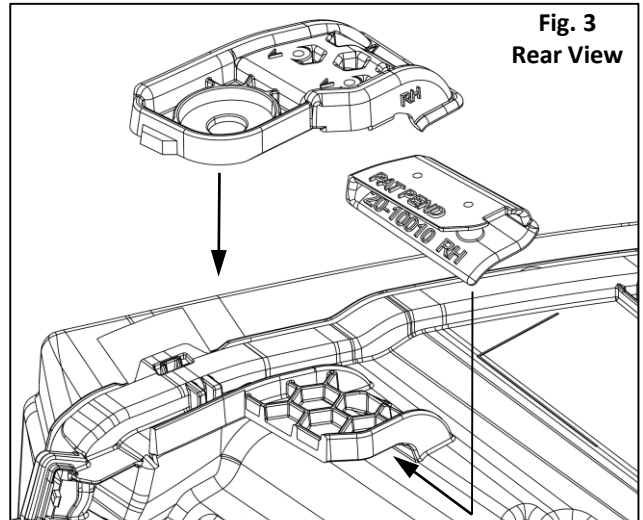
**2. Dry-Fit:** Dry-fit the repair tab(s) **Fig. 3**. If the tab fits without resistance and makes a flush fit to the housing, trimming is complete. If the tab resists installation re-trim the damaged tab, removing only small amounts of material. Repeat the Dry-Fit steps until the proper fit is achieved.

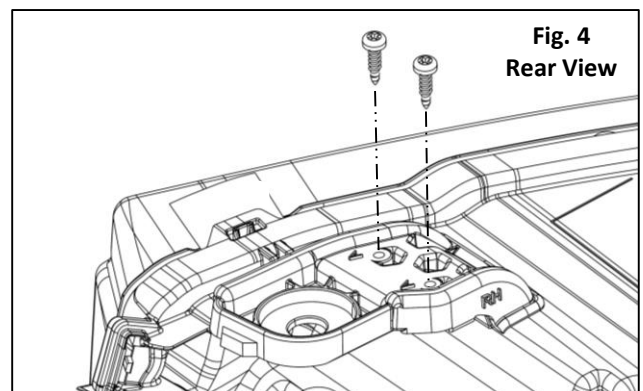
**4. Install:** Install the prepared tab(s) ensuring a flush fit to the housing **Fig. 4**. Next, drive the two 5/8" screws at the locations marked (A). Do not overtighten the screws. Allow the glue to cure for approximately 30 minutes before installing the repaired headlight on the vehicle.

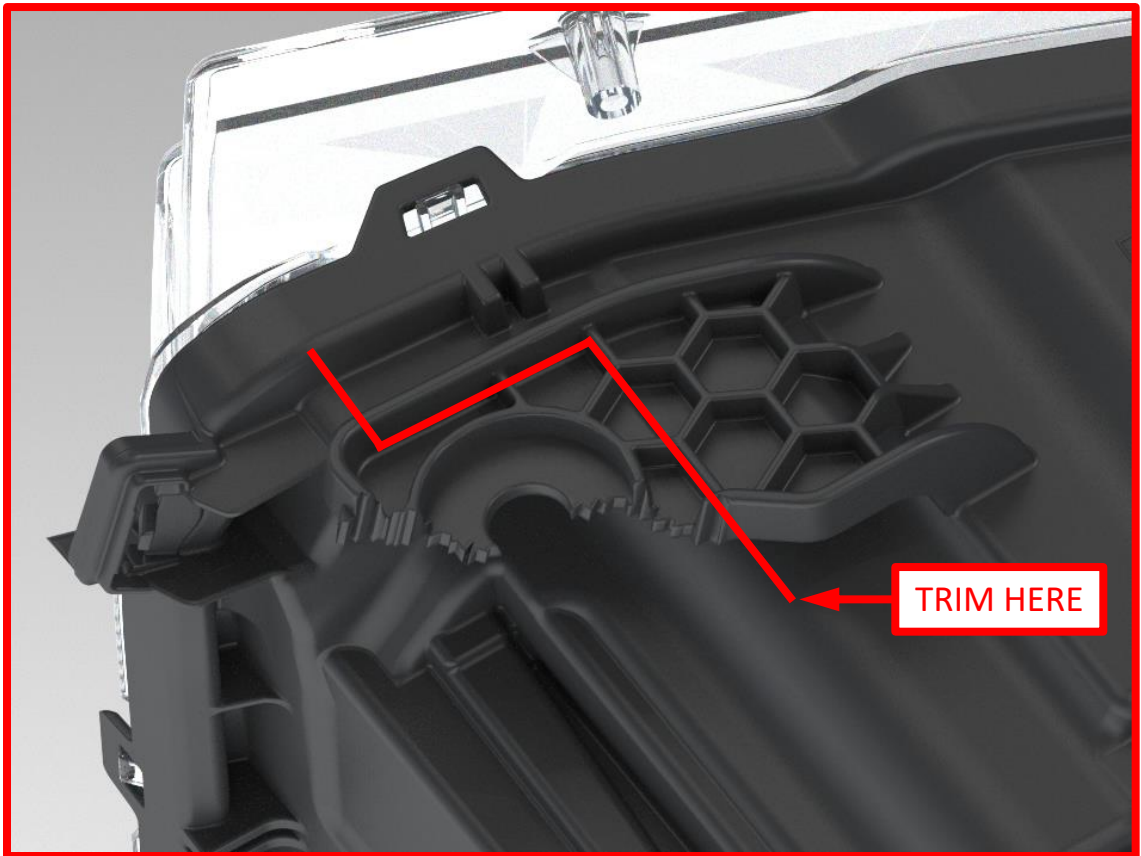
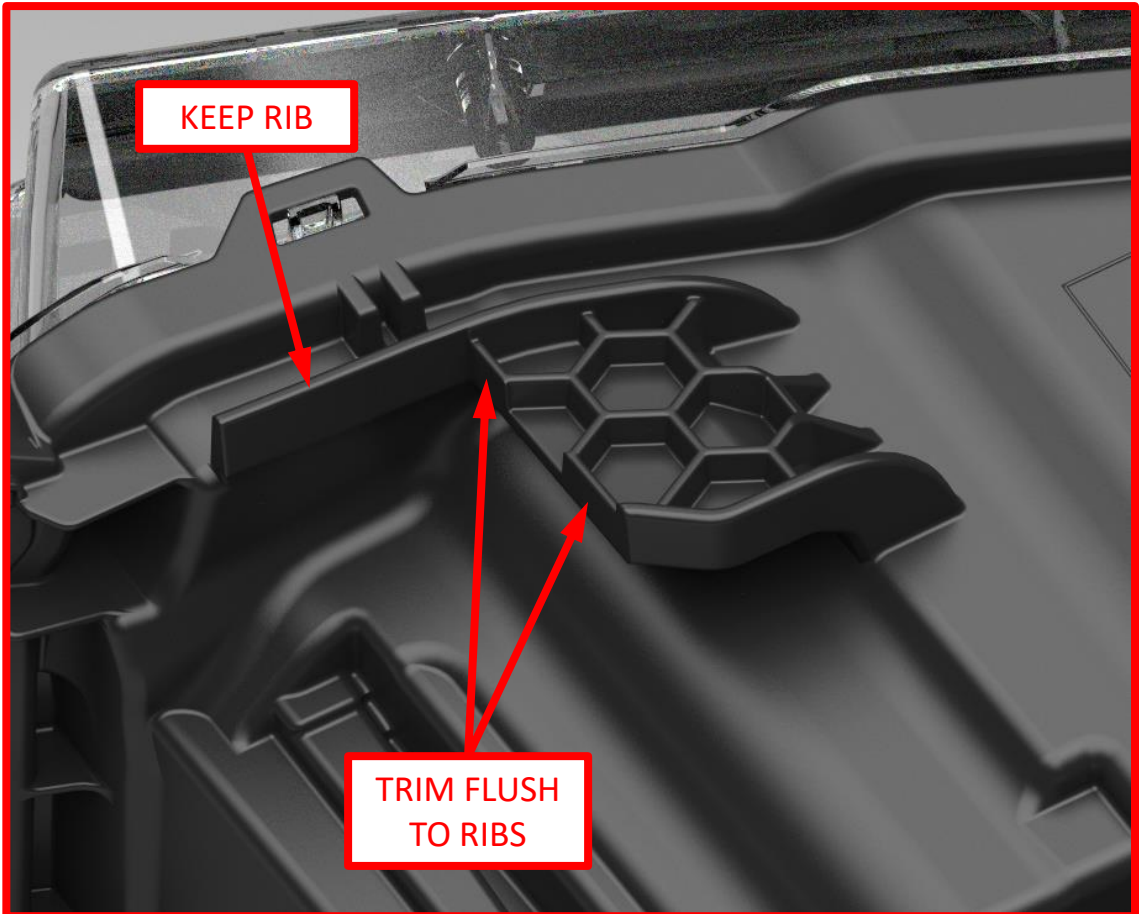
SEE REVERSE SIDE for views of properly trimmed headlamp tab.
