2016-18 CHEVY SILVERADO 1500 HID LED RH UPR OUTBOARD HEADLIGHT TAB KIT P/N 25-10038

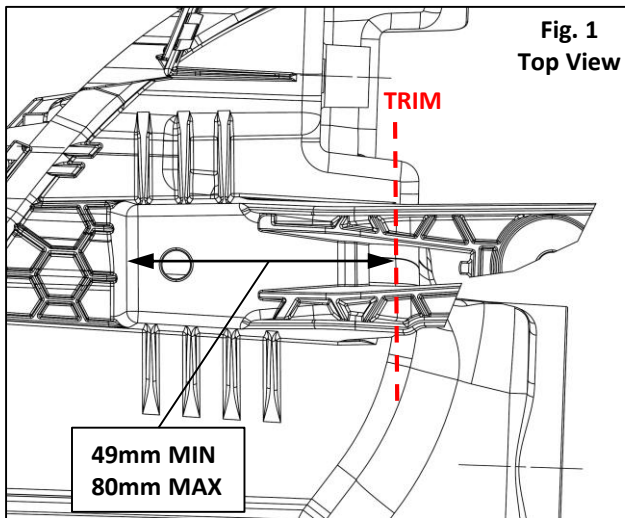
1. Trim: Using a cut-off wheel, trim the damaged tab to the **MAX** dimension whenever possible, **Fig. 1**. Make note of the trimming plane to which the **MAX** dimension refers, **Fig. 2**. The **MIN** indicates the least amount of material allowed for proper screw engagement. Next, Sand rough edges to remove excess material from trimming and to ensure a proper fit.

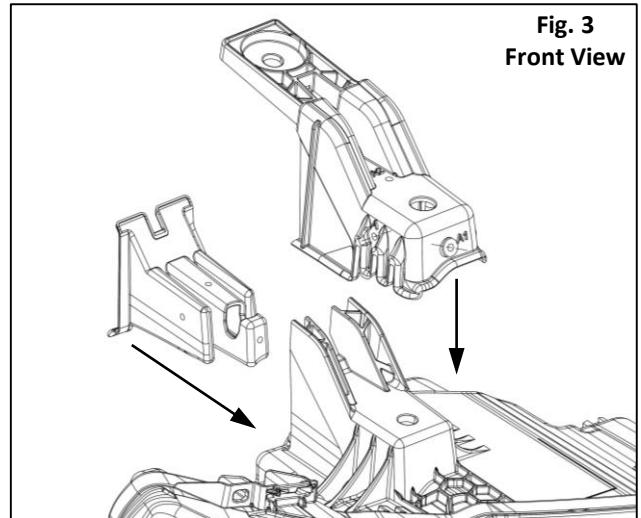
2. Dry-Fit: Dry-fit the repair tab(s) **Fig. 3**. If the tab fits without resistance and makes a flush fit to the housing, trimming is complete. If the tab resists installation re-trim the damaged tab, removing only small amounts of material. Repeat the Dry-Fit steps until the proper fit is achieved.

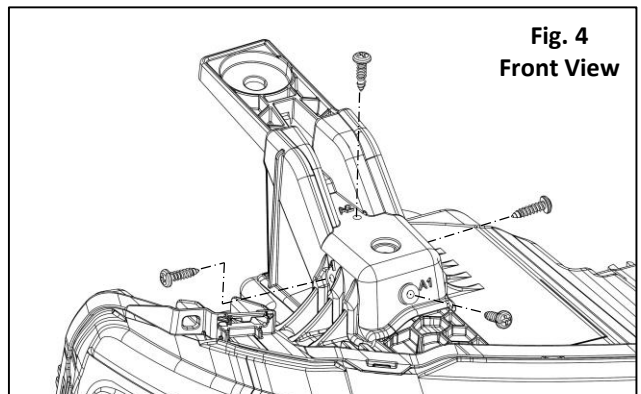
4. Install: Install the prepared tab(s) ensuring a flush fit to the housing **Fig. 4**. Drive the 5/8" screws at the locations marked (A1), followed by (A2) then location (A). Do not overtighten the screws. Allow the glue to cure for approximately 30 minutes before installing the repaired headlight on the vehicle.

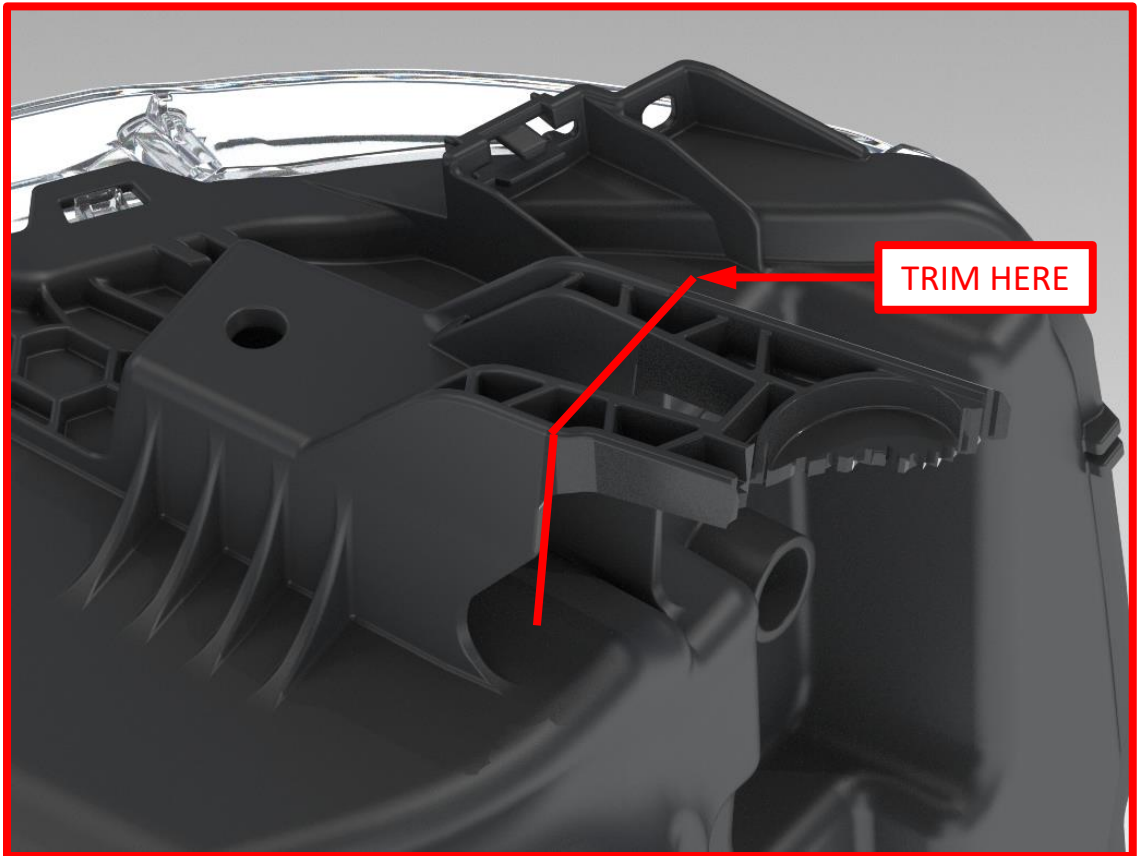
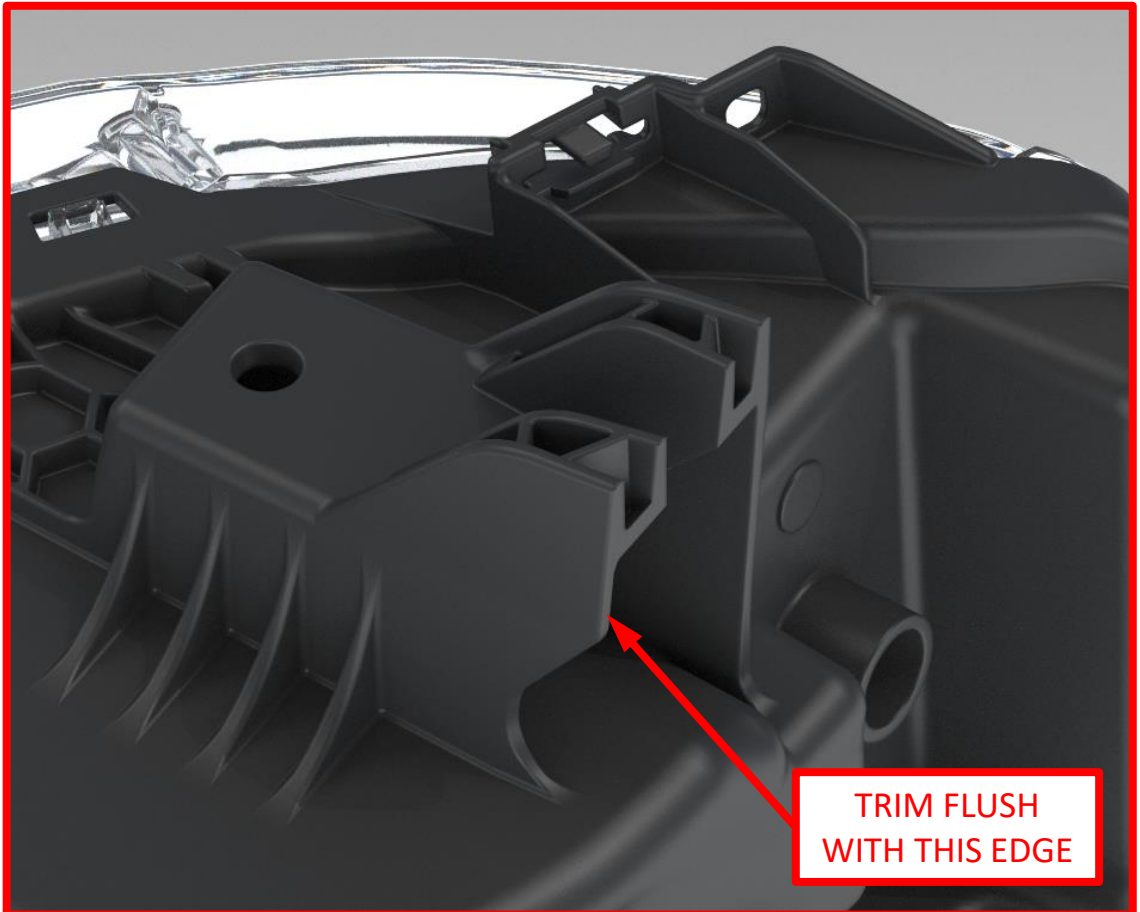
SEE REVERSE SIDE for views of properly trimmed headlamp tab.
