Minimum Material Condition (MMC)
EQUINOX LH UPR MID HEADLIGHT TAB HID
P/N 25-10051

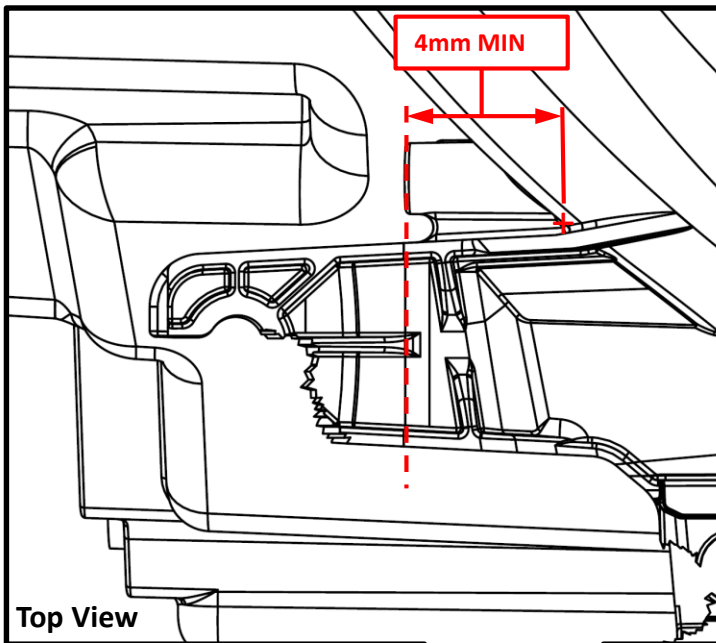
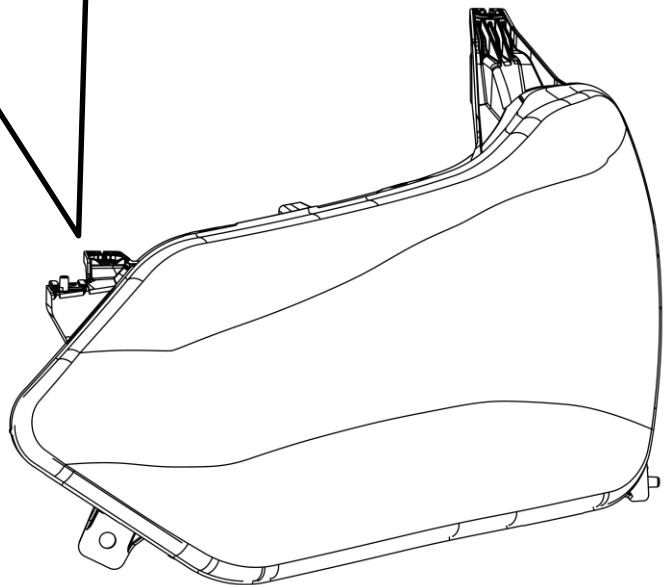
1. Using a metric scale or ruler, measure your lamp at the reference points given in the figure below.
2. If the broken mounting tab meets the Minimum Material Condition value(MIN), then your lamp can be repaired using this kit.
3. If the broken mounting tab does not meet the Minimum Material Condition value(MIN), then your lamp is not a candidate for this repair kit.
4. If your lamp's mounting tabs have been repaired previously by any method, then your lamp is not a candidate for this repair kit.
