Minimum Material Condition (MMC)
F150 LH LWR IB HEADLIGHT TAB HAL
P/N 25-10133

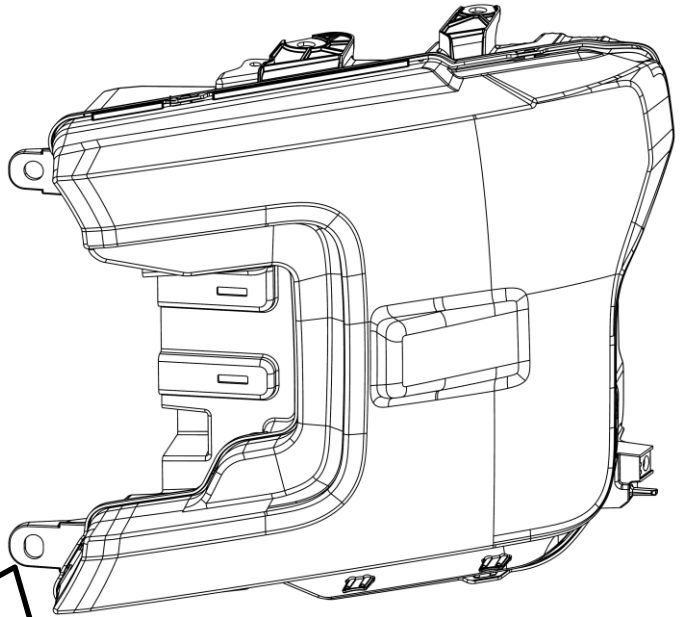
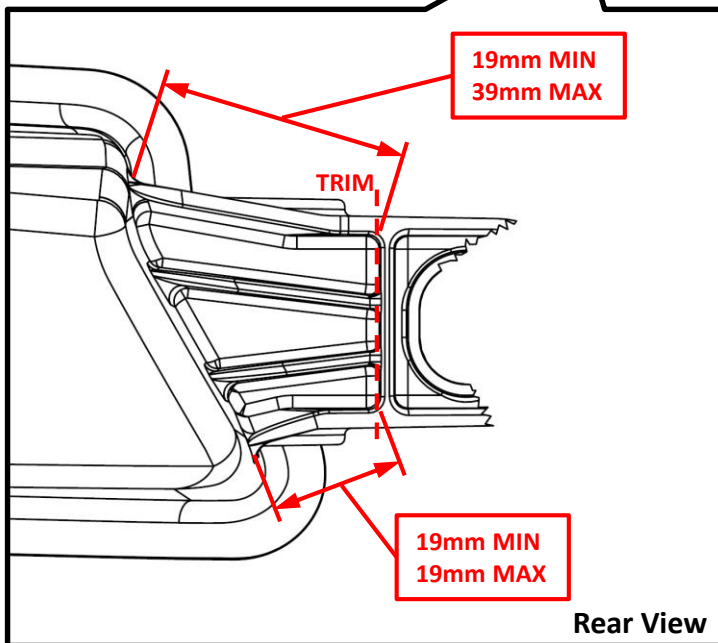
1. Using a metric scale or ruler, measure your lamp at the reference points given in the figure below.
2. If the broken mounting tab meets the Minimum Material Condition value(MIN), then your lamp can be repaired using this kit.
3. If the broken mounting tab does not meet the Minimum Material Condition value(MIN), then your lamp is not a candidate for this repair kit.
4. If your lamp's mounting tabs have been repaired previously by any method, then your lamp is not a candidate for this repair kit.
