Minimum Material Condition (MMC)
F150 LH UPR OB HEADLIGHT TAB HAL
P/N 25-10130

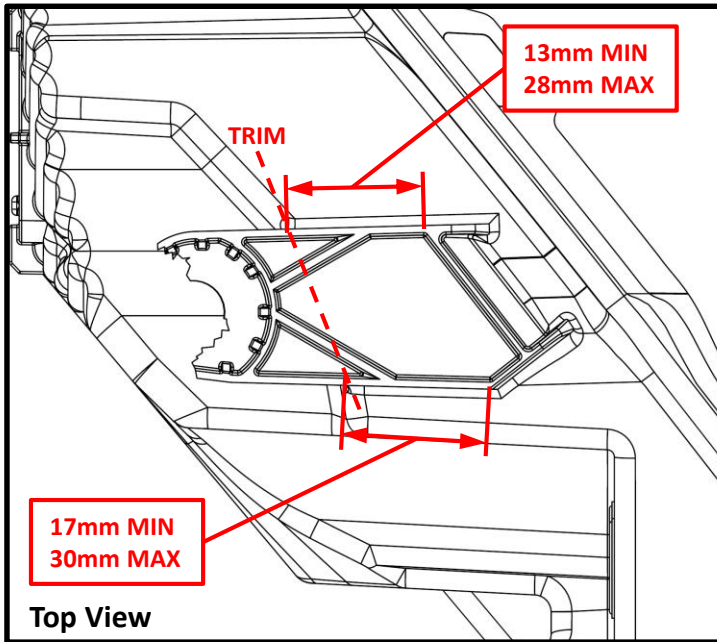
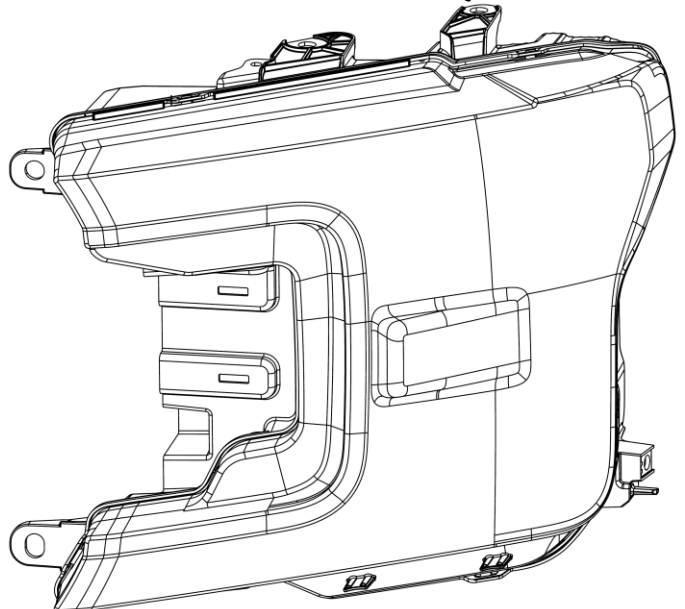
1. Using a metric scale or ruler, measure your lamp at the reference points given in the figure below.
2. If the broken mounting tab meets the Minimum Material Condition value(MIN), then your lamp can be repaired using this kit.
3. If the broken mounting tab does not meet the Minimum Material Condition value(MIN), then your lamp is not a candidate for this repair kit.
4. If your lamp's mounting tabs have been repaired previously by any method, then your lamp is not a candidate for this repair kit.
