Minimum Material Condition (MMC)
F150 LH UPR OB HEADLIGHT TAB LED
P/N 25-10120

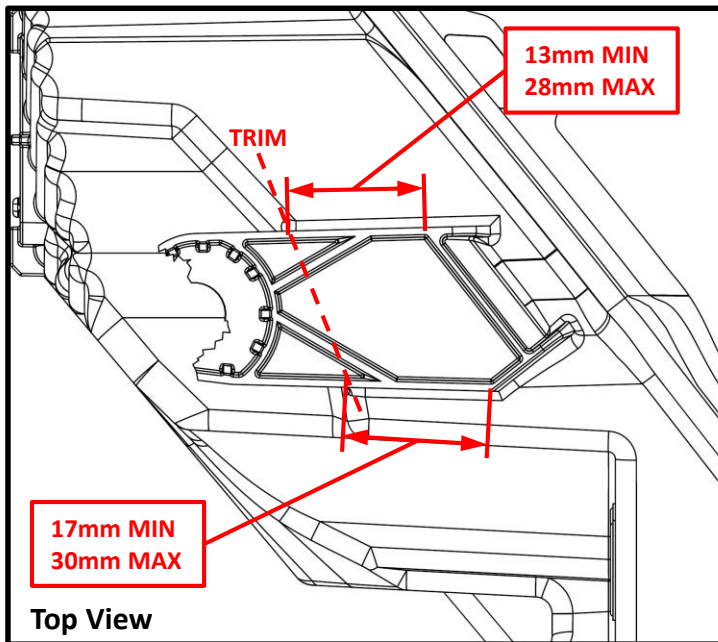
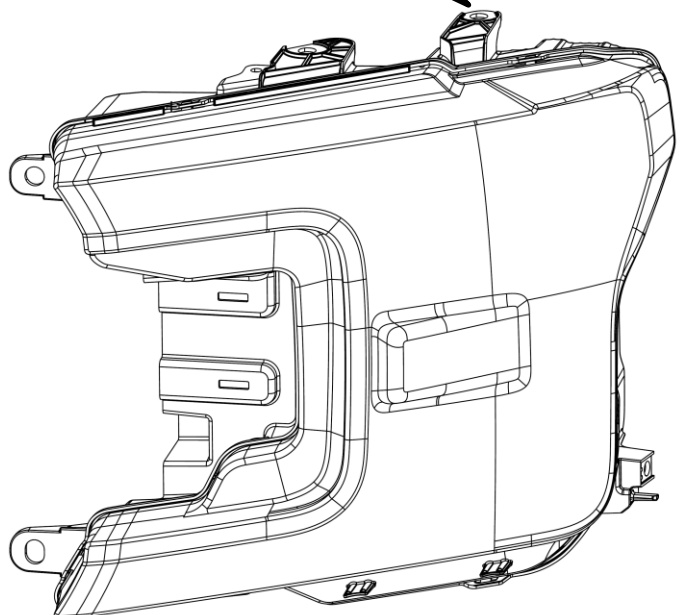
1. Using a metric scale or ruler, measure your lamp at the reference points given in the figure below.
2. If the broken mounting tab meets the Minimum Material Condition value(MIN), then your lamp can be repaired using this kit.
3. If the broken mounting tab does not meet the Minimum Material Condition value(MIN), then your lamp is not a candidate for this repair kit.
4. If your lamp's mounting tabs have been repaired previously by any method, then your lamp is not a candidate for this repair kit.
