Minimum Material Condition (MMC)
F150 RH LWR IB HEADLIGHT TAB HAL
P/N 25-10128

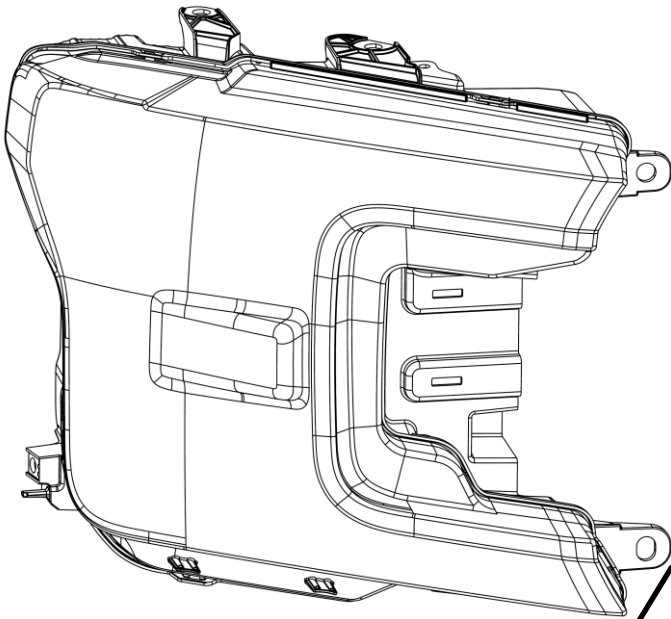
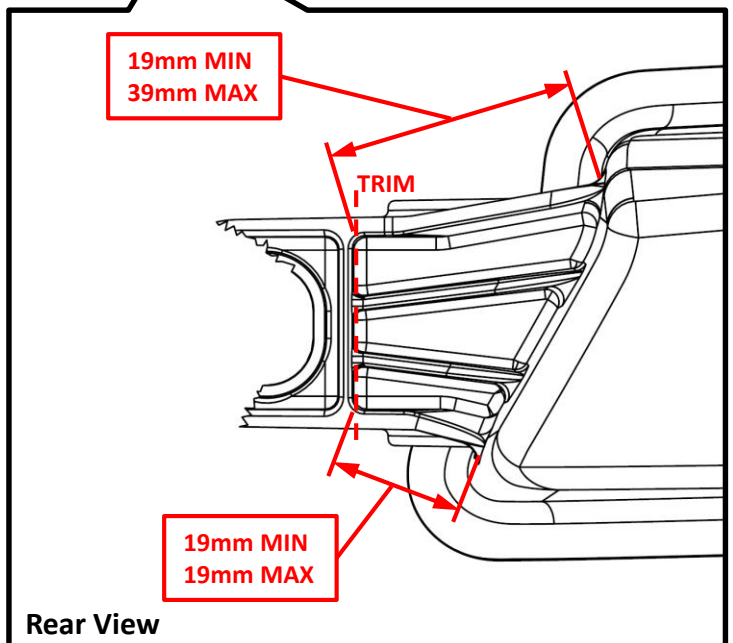
1. Using a metric scale or ruler, measure your lamp at the reference points given in the figure below.
2. If the broken mounting tab meets the Minimum Material Condition value(MIN), then your lamp can be repaired using this kit.
3. If the broken mounting tab does not meet the Minimum Material Condition value(MIN), then your lamp is not a candidate for this repair kit.
4. If your lamp's mounting tabs have been repaired previously by any method, then your lamp is not a candidate for this repair kit.
