Minimum Material Condition (MMC)
F150 RH LWR IB HEADLIGHT TAB LED
P/N 25-10118

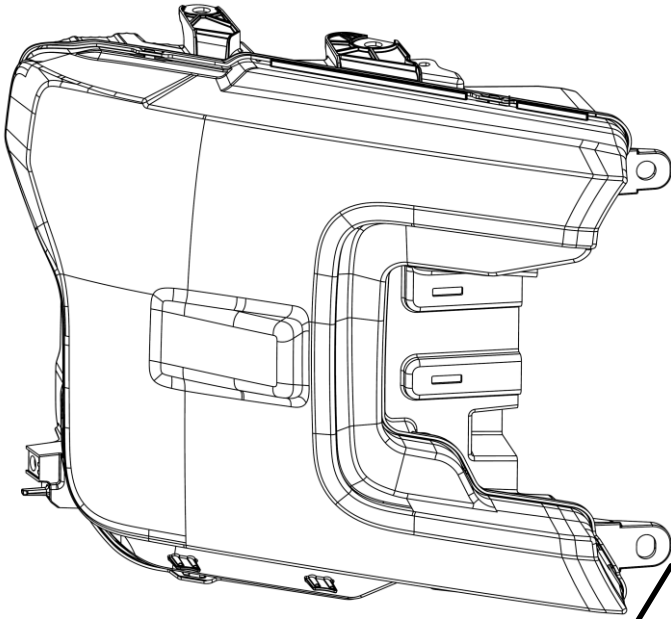
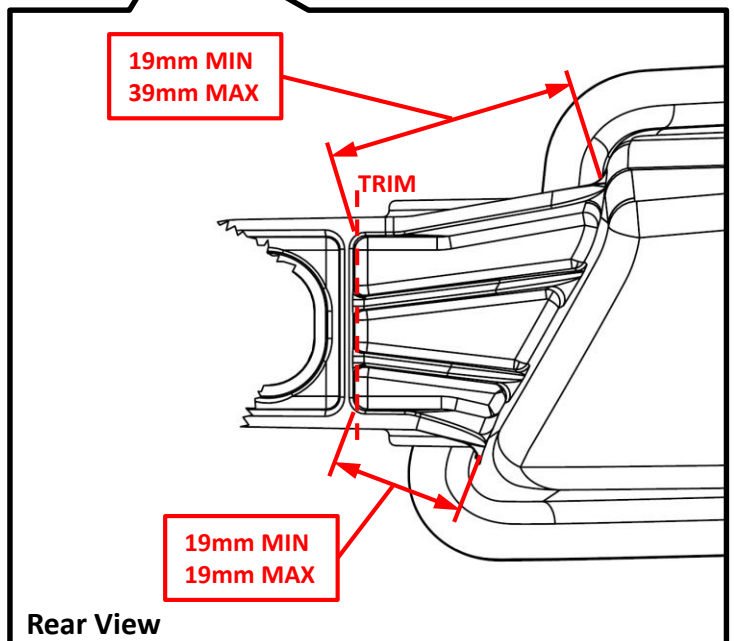
1. Using a metric scale or ruler, measure your lamp at the reference points given in the figure below.
2. If the broken mounting tab meets the Minimum Material Condition value(MIN), then your lamp can be repaired using this kit.
3. If the broken mounting tab does not meet the Minimum Material Condition value(MIN), then your lamp is not a candidate for this repair kit.
4. If your lamp's mounting tabs have been repaired previously by any method, then your lamp is not a candidate for this repair kit.
