## 2014-18 GMC SIERRA RH LWR INBOARD HEADLIGHT TAB KIT ALL

P/N 25-10004

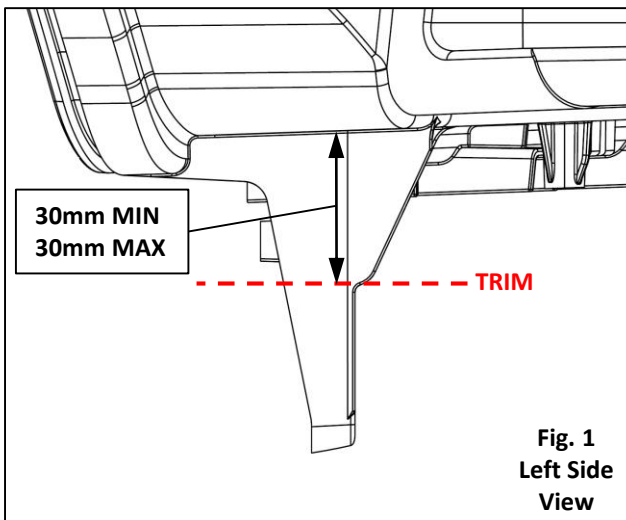
**1. Trim:** Using a cut-off wheel, trim the damaged tab to the **MAX** dimension whenever possible, **Fig. 1**. Make note of the trimming plane to which the **MAX** dimension refers, **Fig. 2**. The **MIN** indicates the least amount of material allowed for proper screw engagement. Next, Sand rough edges to remove excess material from trimming and to ensure a proper fit.

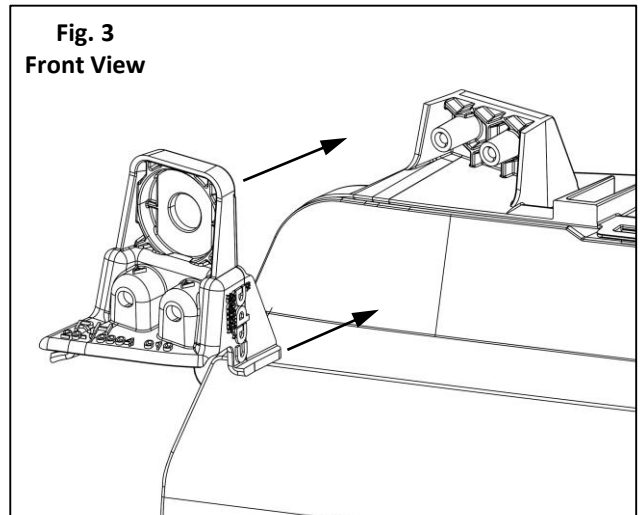
**2. Dry-Fit:** Dry-fit the repair tab(s) **Fig. 3**. If the tab fits without resistance and makes a flush fit to the housing, trimming is complete. If the tab resists installation re-trim the damaged tab, removing only small amounts of material. Repeat the Dry-Fit steps until the proper fit is achieved.

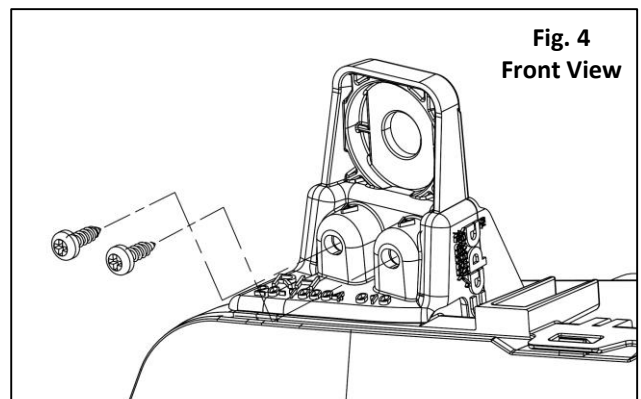
**4. Install:** Install the prepared tab(s) ensuring a flush fit to the housing **Fig. 4**. Next, drive the two 5/8" screws at the locations marked (A). Do not over-tighten the screws. Allow the glue to cure for approximately 30 minutes before installing the repaired headlight on the vehicle.

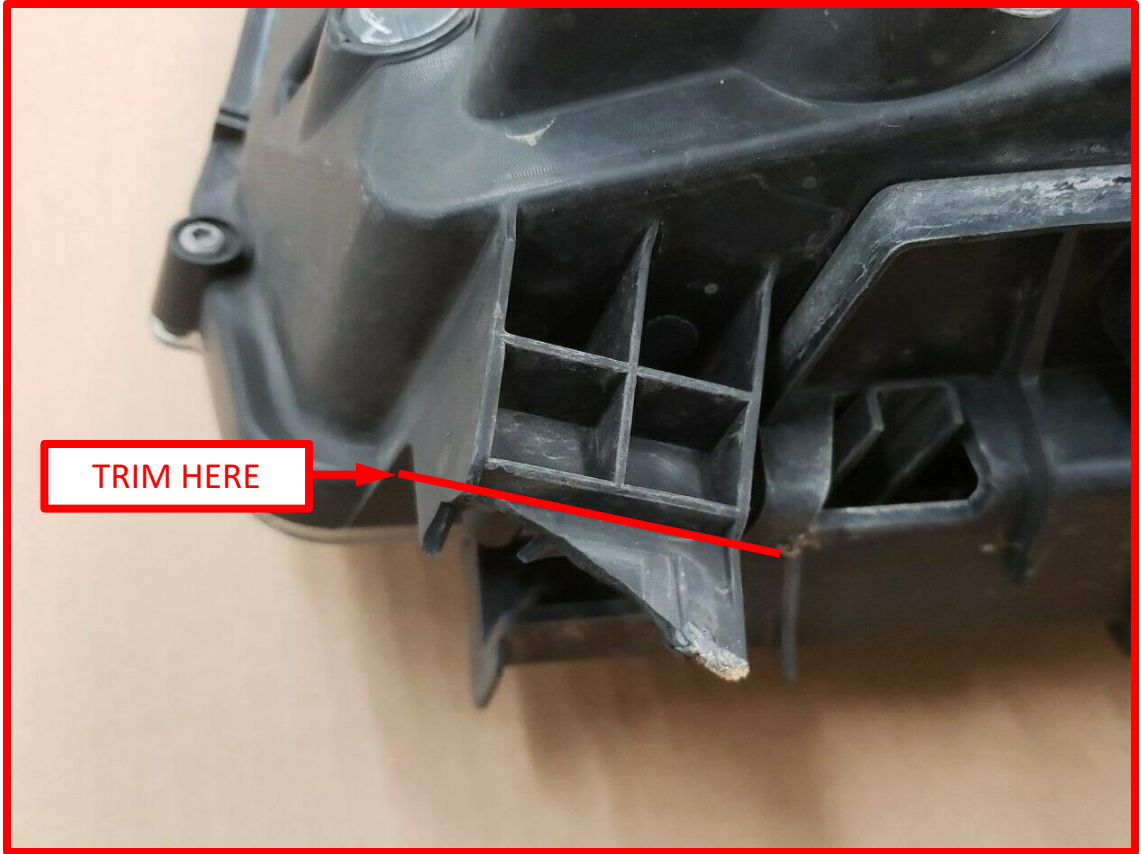
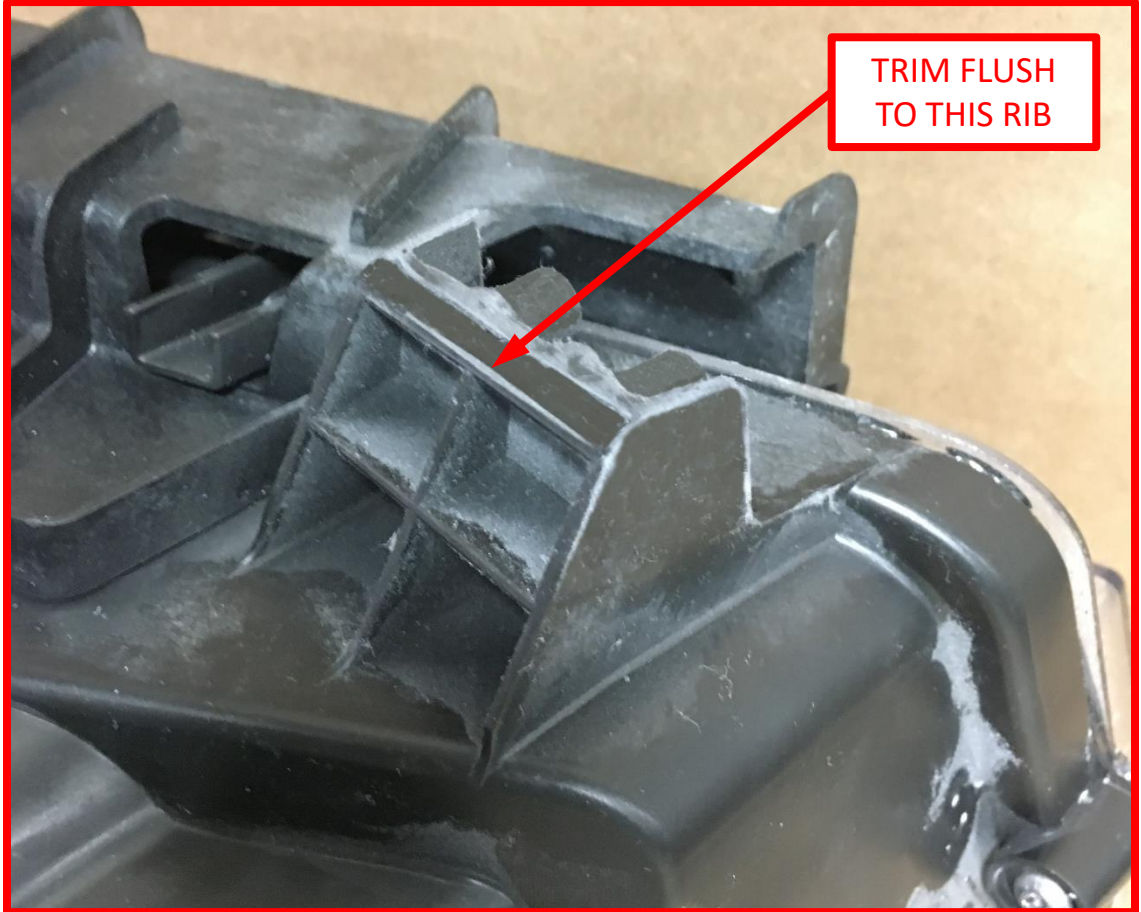
SEE REVERSE SIDE for views of properly trimmed headlamp tab.
