2016-18 CHEVY SILVERADO 1500 HID LED LH LWR INBOARD HEADLIGHT TAB KIT P/N 25-10044

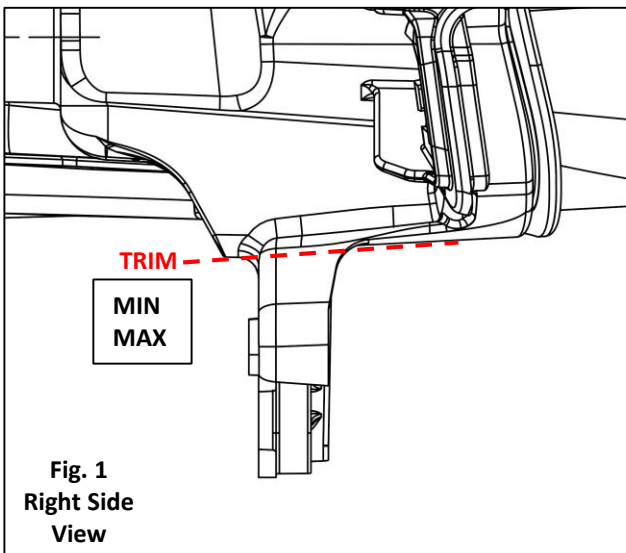
1. Trim: Using a cut-off wheel, trim the damaged tab to the **MAX** dimension whenever possible, **Fig. 1**. Make note that in this case the trimming line is both the **MIN** and **MAX** dimension, **Fig. 1**. Trim flush to the plane marked **MIN MAX**, **Fig. 2** Next, Sand rough edges to remove excess material from trimming and to ensure a proper fit.

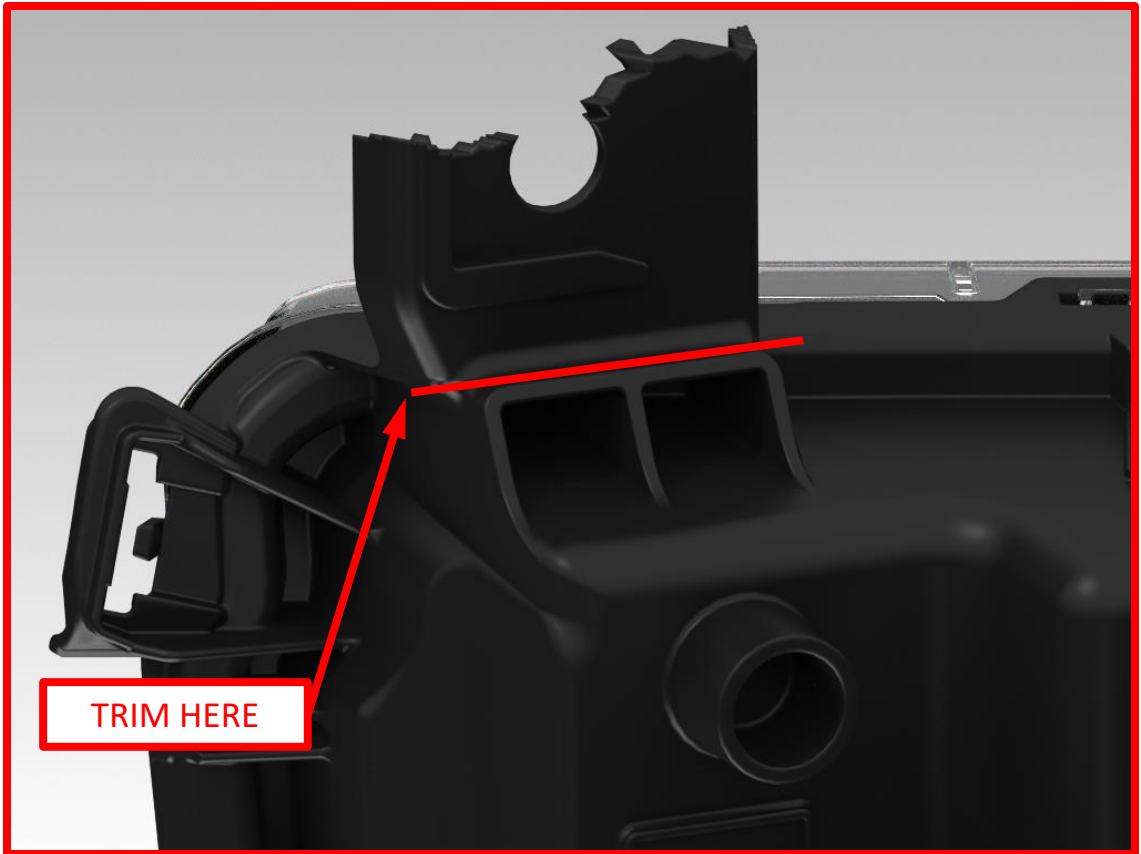
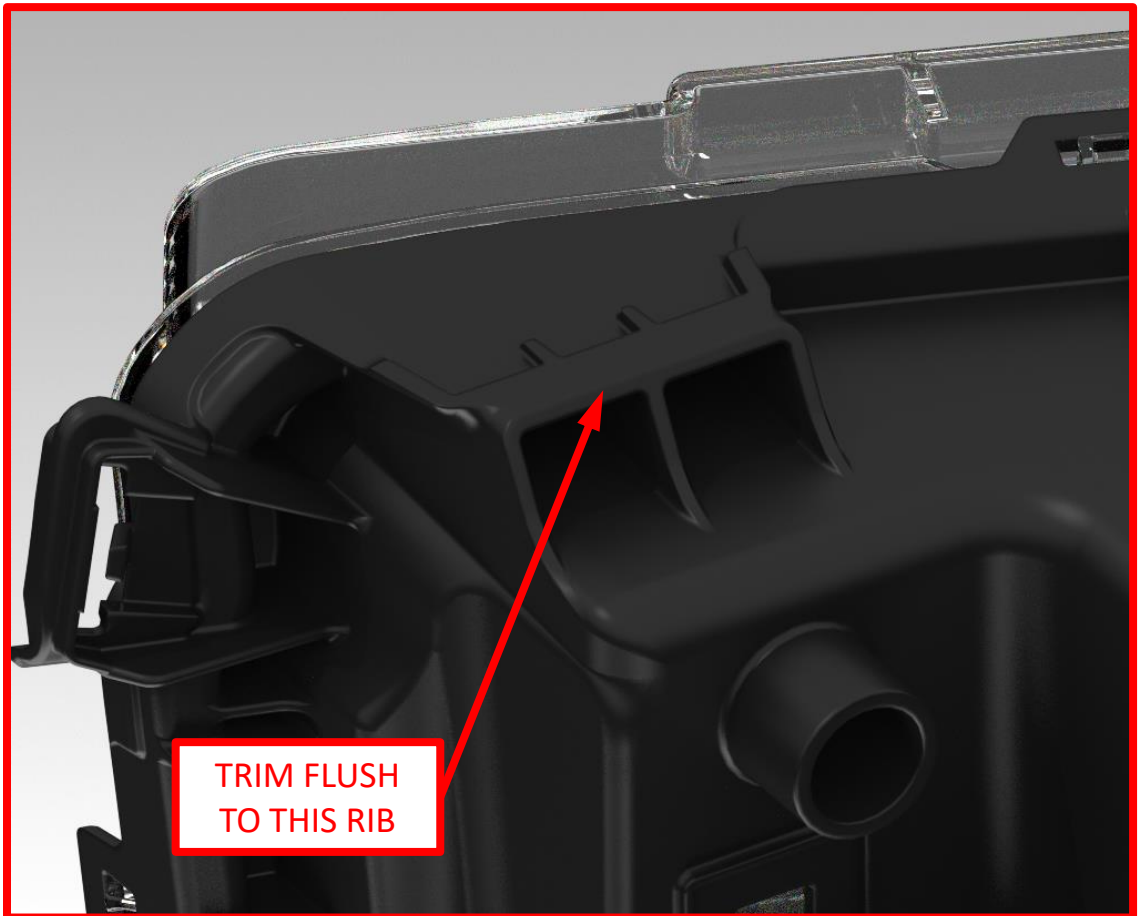
SEE REVERSE SIDE for views of properly trimmed headlamp tab.
