Minimum Material Condition (MMC)
EQUINOX LH LWR INBOARD HEADLIGHT TAB LED
P/N 25-10063

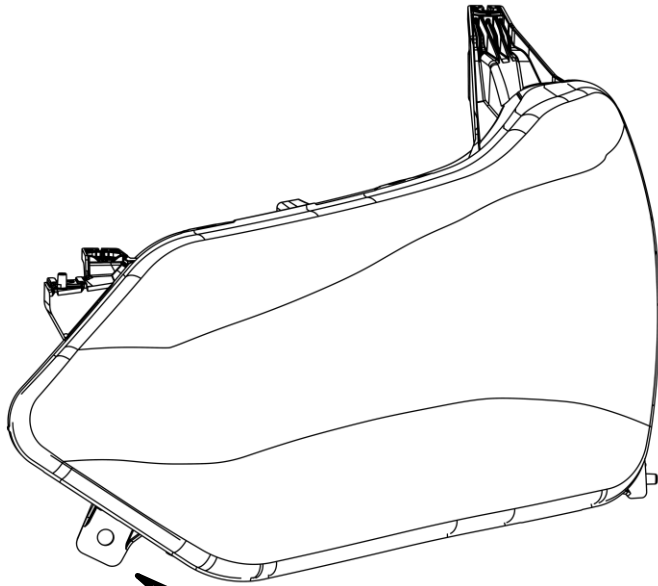
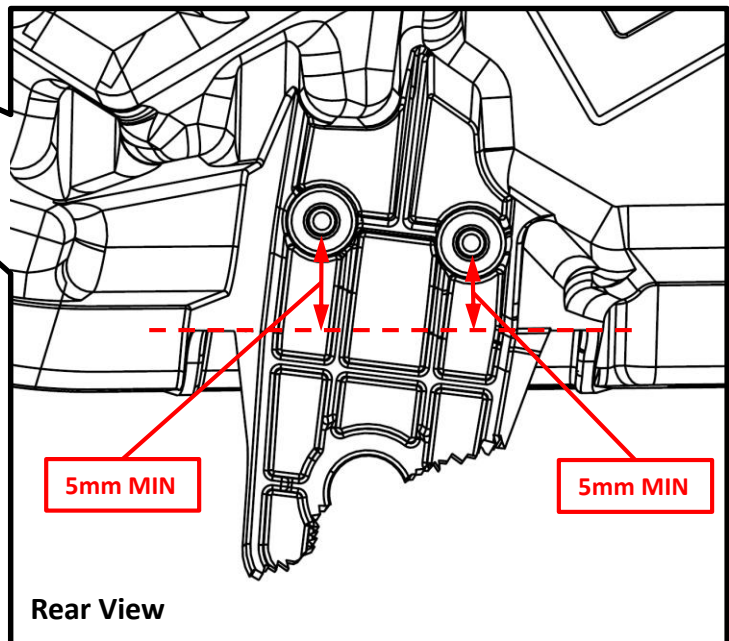
1. Using a metric scale or ruler, measure your lamp at the reference points given in the figure below.
2. If the broken mounting tab meets the Minimum Material Condition value(MIN), then your lamp can be repaired using this kit.
3. If the broken mounting tab does not meet the Minimum Material Condition value(MIN), then your lamp is not a candidate for this repair kit.
4. If your lamp's mounting tabs have been repaired previously by any method, then your lamp is not a candidate for this repair kit.
