**Minimum Material Condition (MMC)**  
**EQUINOX RH LWR INBOARD HEADLIGHT TAB LED**  
**P/N 25-10058**

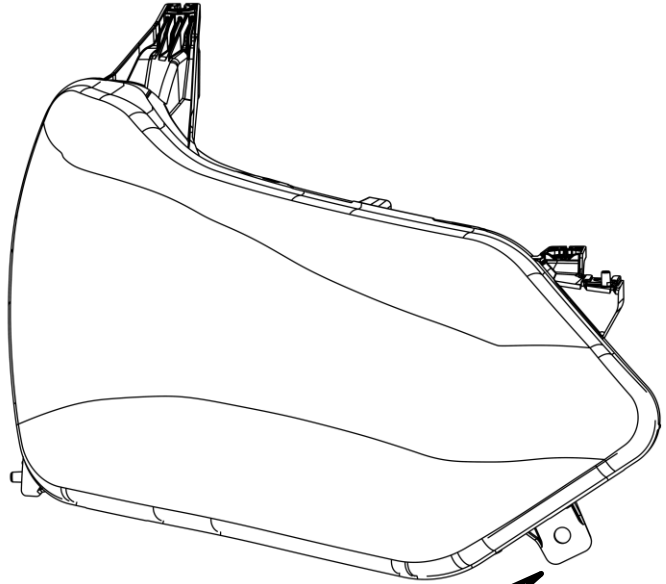
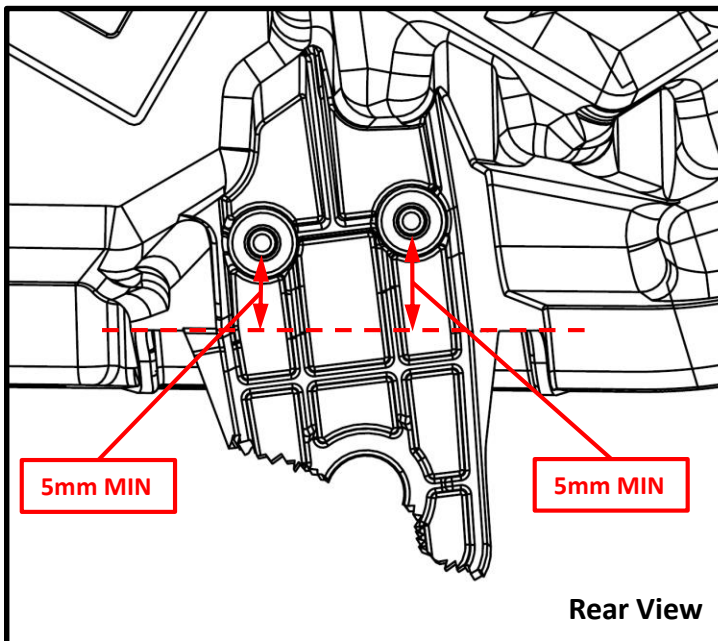
1. Using a metric scale or ruler, measure your lamp at the reference points given in the figure below.
2. If the broken mounting tab meets the Minimum Material Condition value(MIN), then your lamp can be repaired using this kit.
3. If the broken mounting tab does not meet the Minimum Material Condition value(MIN), then your lamp is not a candidate for this repair kit.
4. If your lamp's mounting tabs have been repaired previously by any method, then your lamp is not a candidate for this repair kit.
