Minimum Material Condition (MMC)
TAHOE/SUBURBAN LH UPR OUTBOARD HEADLIGHT TAB HID
P/N 25-10080

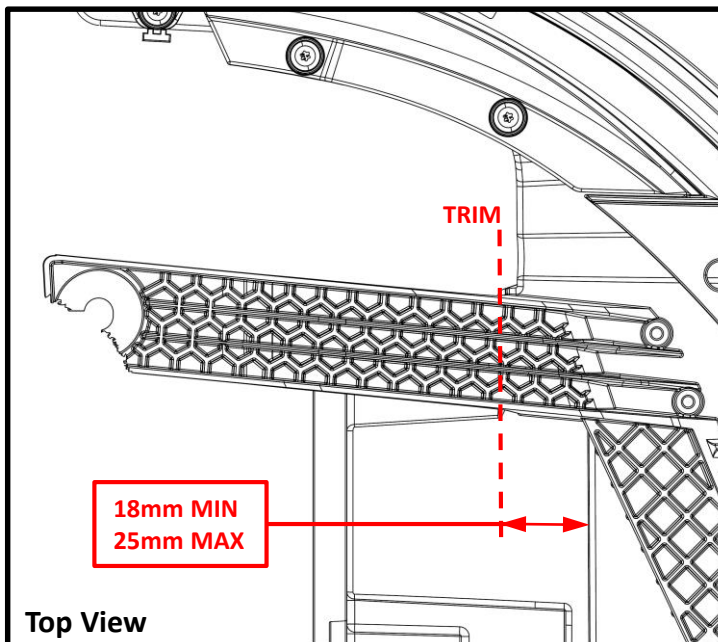
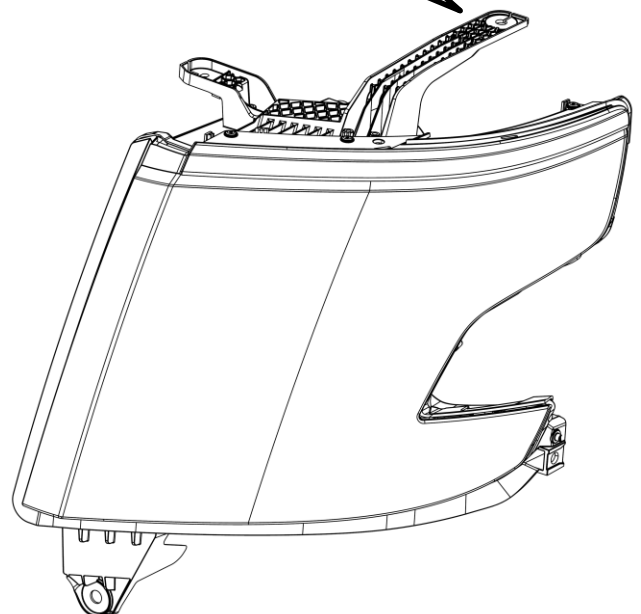
1. Using a metric scale or ruler, measure your lamp at the reference points given in the figure below.
2. If the broken mounting tab meets the Minimum Material Condition value(MIN), then your lamp can be repaired using this kit.
3. If the broken mounting tab does not meet the Minimum Material Condition value(MIN), then your lamp is not a candidate for this repair kit.
4. If your lamp's mounting tabs have been repaired previously by any method, then your lamp is not a candidate for this repair kit.
