Minimum Material Condition (MMC)
TAHOE/SUBURBAN RH LWR INBOARD HEADLIGHT TAB HAL
P/N 25-10097

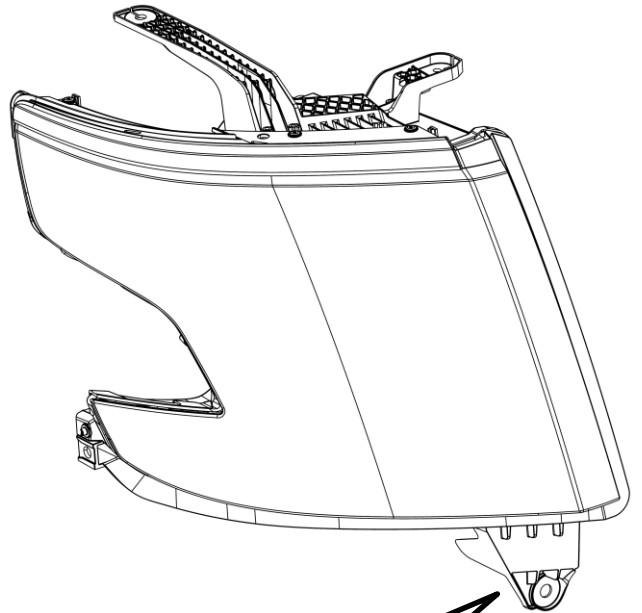
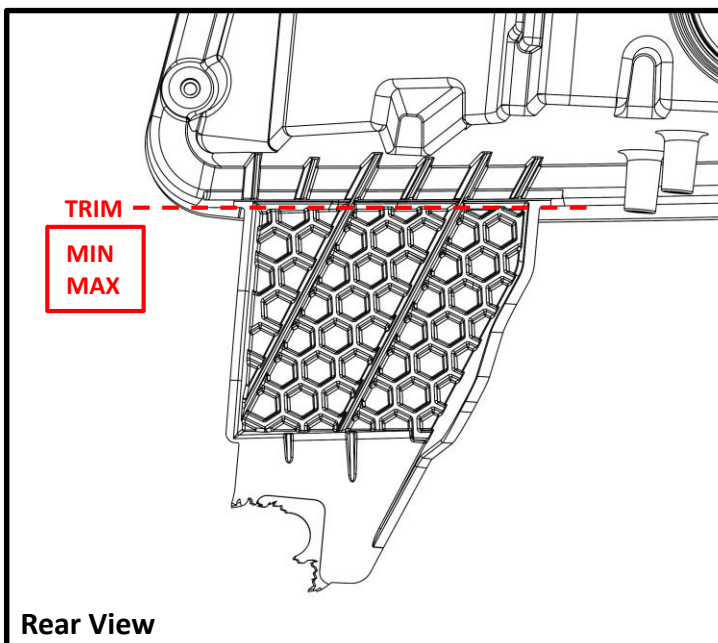
1. Using a metric scale or ruler, measure your lamp at the reference points given in the figure below.
2. If the broken mounting tab meets the Minimum Material Condition value(MIN), then your lamp can be repaired using this kit.
3. If the broken mounting tab does not meet the Minimum Material Condition value(MIN), then your lamp is not a candidate for this repair kit.
4. If your lamp's mounting tabs have been repaired previously by any method, then your lamp is not a candidate for this repair kit.
