F150 LH UPR IB HEADLIGHT TAB HAL P/N 25-10132

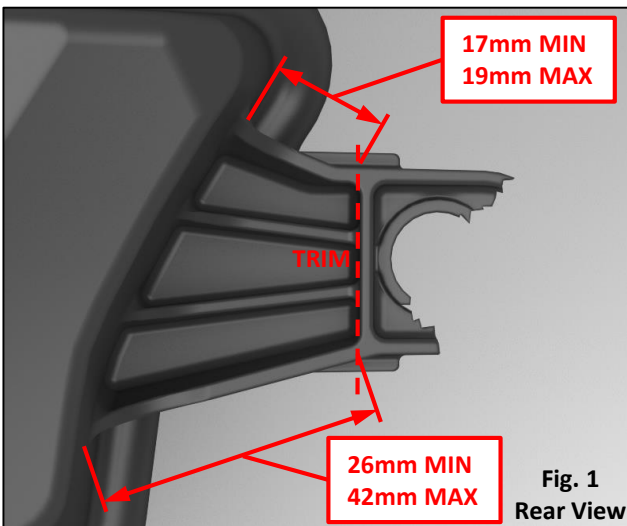
Fig. 1
Rear View

1. Trim: Using a cut-off wheel, trim the damaged tab to the **MAX** dimension whenever possible, **Fig. 1**. Make note of the trimming plane to which the **MAX** dimension refers, **Fig. 2**. The **MIN** indicates the least amount of material allowed for proper screw engagement. Next, Sand rough edges to remove excess material from trimming and to ensure a proper fit.

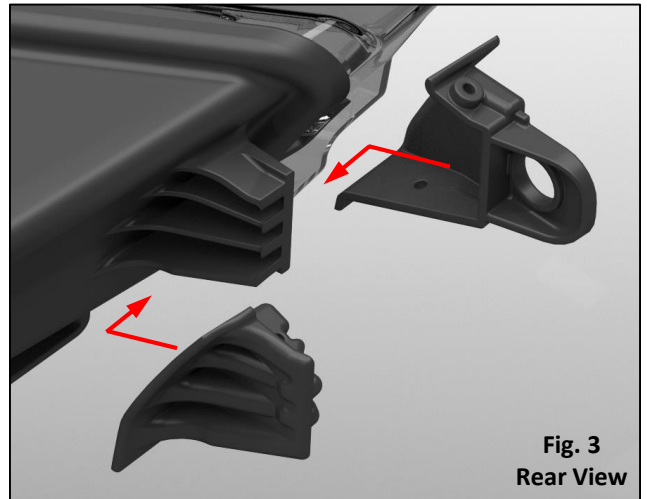
Fig. 3
Rear View

2. Dry-Fit: Dry-fit the repair tab(s) **Fig. 3**. If the tab fits without resistance and makes a flush fit to the housing, trimming is complete. If the tab resists installation re-trim the damaged tab, removing only small amounts of material. Repeat the Dry-Fit steps until the proper fit is achieved.
