## F150 LH UPR IB HEADLIGHT TAB LED P/N 25-10122

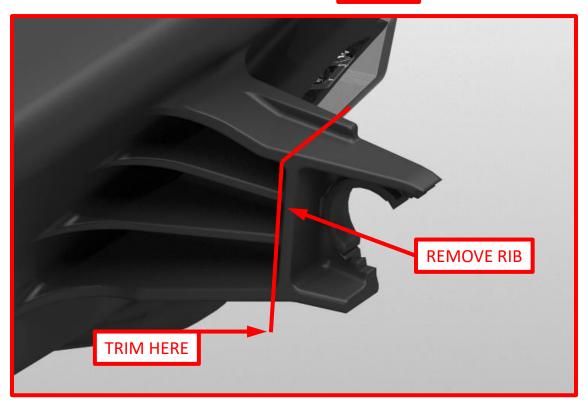
1. Trim: Using a cut-off wheel, trim the damaged tab to the MAX dimension whenever possible, Fig. 1. Make note of the trimming plane to which the MAX dimension refers, Fig. 2. The MIN indicates the least amount of material allowed for proper screw engagement. Next, Sand rough edges to remove excess material from trimming and to ensure a proper fit.

**2. Dry-Fit:** Dry-fit the repair tab(s) **Fig. 3**. If the tab fits without resistance and makes a flush fit to the housing, trimming is complete. If the tab resists installation re-trim the damaged tab, removing only small amounts of material. Repeat the Dry-Fit steps until the proper fit is achieved.
