F150 RH UPR OB HEADLIGHT TAB HAL P/N 25-10125

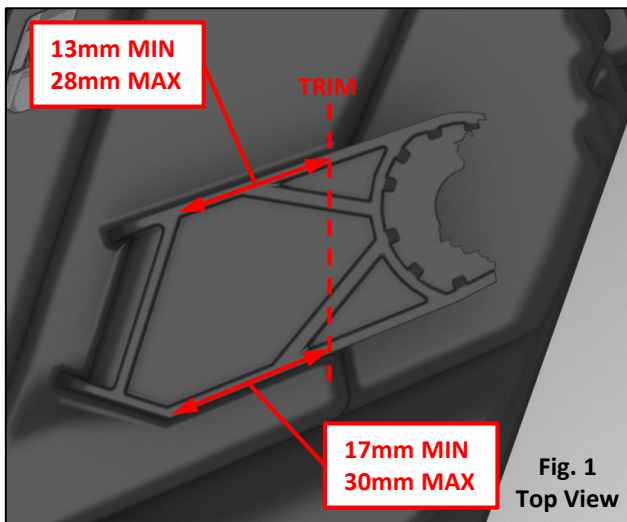
Fig. 1
Top View

1. Trim: Using a cut-off wheel, trim the damaged tab to the **MAX** dimension whenever possible, **Fig. 1**. Make note of the trimming plane to which the **MAX** dimension refers, **Fig. 2**. The **MIN** indicates the least amount of material allowed for proper screw engagement. Next, Sand rough edges to remove excess material from trimming and to ensure a proper fit.
